Village of Sherman Comprehensive Water and Stormwater Assessment Studies

CDBG Planning Grant Public Hearing

February 5, 2020

Comprehensive Water Assessment Study

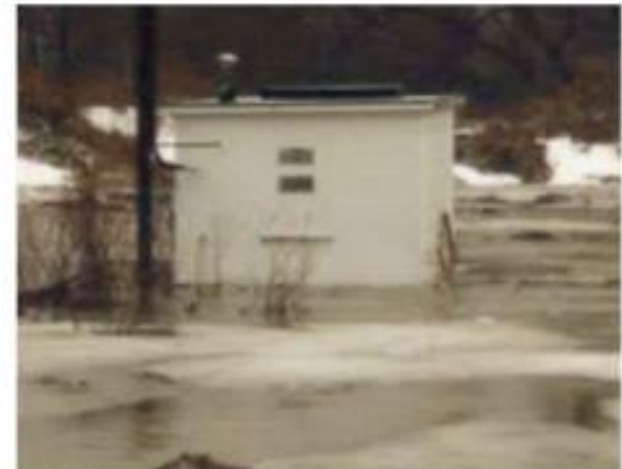
Historic Photo of Flooding Around Well House No. 2

6	Well Building No. 2 is half buried and in extremely poor condition. This well house needs to be replaced in its entirety. The Well Building is located in the 100 year flood plain and is not protected from flooding. This well building has been reported by CCDOH to experienced flooding in the past. These items are noted violations by the CCDOH and can result in untreated surface water entering the public water supply.
7	The critical valve outside Well No. 1 is in operable and needs to be replaced. This is a noted violation by the CCDOH.
8	The monitoring well outside of Well House No. 2 is damaged and needs to be properly decommissioned. This is a noted violation by the CCDOH.
9	The chemical disinfection equipment (dosing pumps, piping, injection quills, containment, etc.) has exceeded their useful lives and are in need of replacement.
10	The current process of disinfecting Well No. 1 is unacceptable. Due to a failed injection quill, unchlorinated water from Well No. 1 is blended with over chlorinated water from Well No. 2 to achieve a proper chlorine residual. This is a noted violation by the CCDOH.

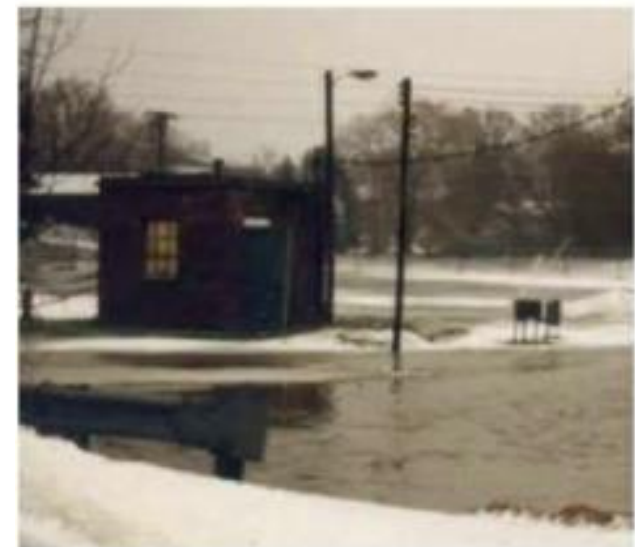
Historic Photo of Flooding Around Well House No. 1

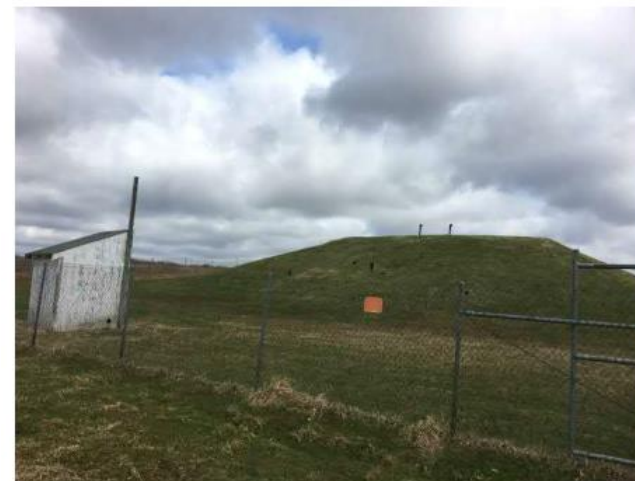
Water Storage Tank and System Pressures

Deficiency No.	Description
13	The water tank does not have any level sensor, level alarms, or monitoring systems. Operators have to go the water tank site every day and sometimes multiple times a day to check the tank level and plan well pump operation. This is a noted violation by the CCDOH.
14	The tank access hatches are located flush with surrounding grade and need to be raised a minimum of 24-inches. This is a noted violation by the CCDOH.
15	Approximately three (3) homes experience pressures of less than 35 PSI during normal system operation and one (1) house would experience a residual pressure less than 20 PSI during fire flow conditions. This is a noted violation by the CCDOH.

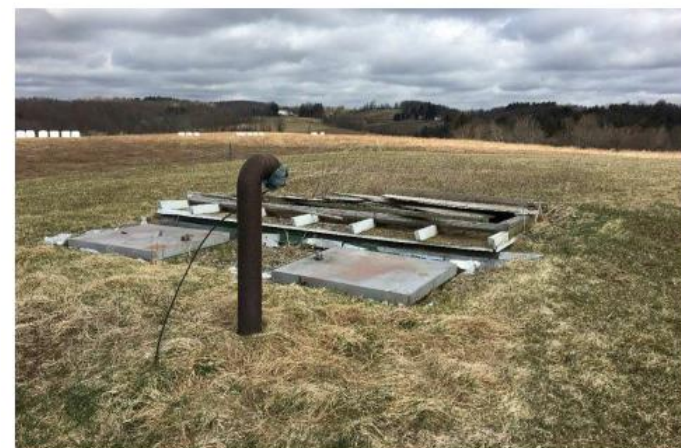
Water Distribution and Transmission

Deficiency No.	Description
16	There are various sections of water main have reached the end of their useful lives and needs to be replaced. This is a noted violation by the CCDOH.
17	There are various sections of antiquated redundant sections of water main that need any remaining water services transferred off of them and be decommissioned. This is a noted violation by the CCDOH.

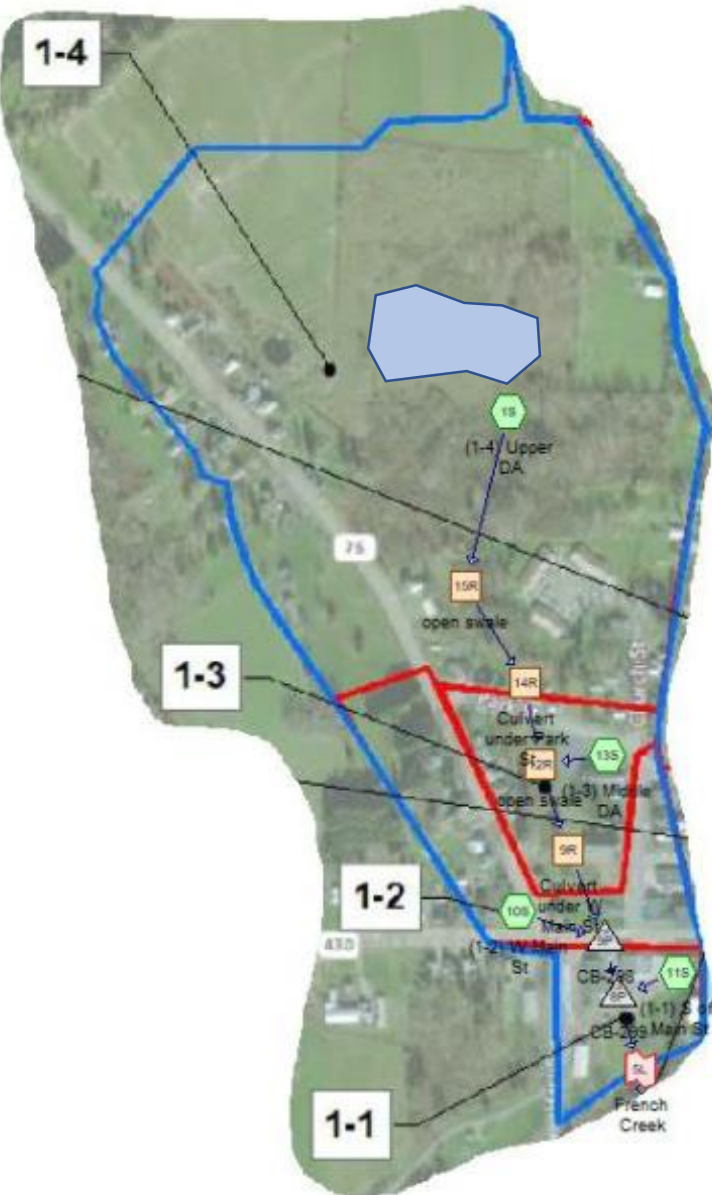
Figure 3-2: DA-1 Model

Storm Event	Modeled Peak Flow at Outlet (cfs)	Modeled Peak Flow at Outlet(cfs)
1-Year Storm	59	10
1.5-Year Storm	59	13
2-Year Storm	60	15
10-Year Storm	71	33
25-Year Storm	78	49
50-Year Storm	85	63
100-Year Storm	94	81
500-Year Storm	123	138

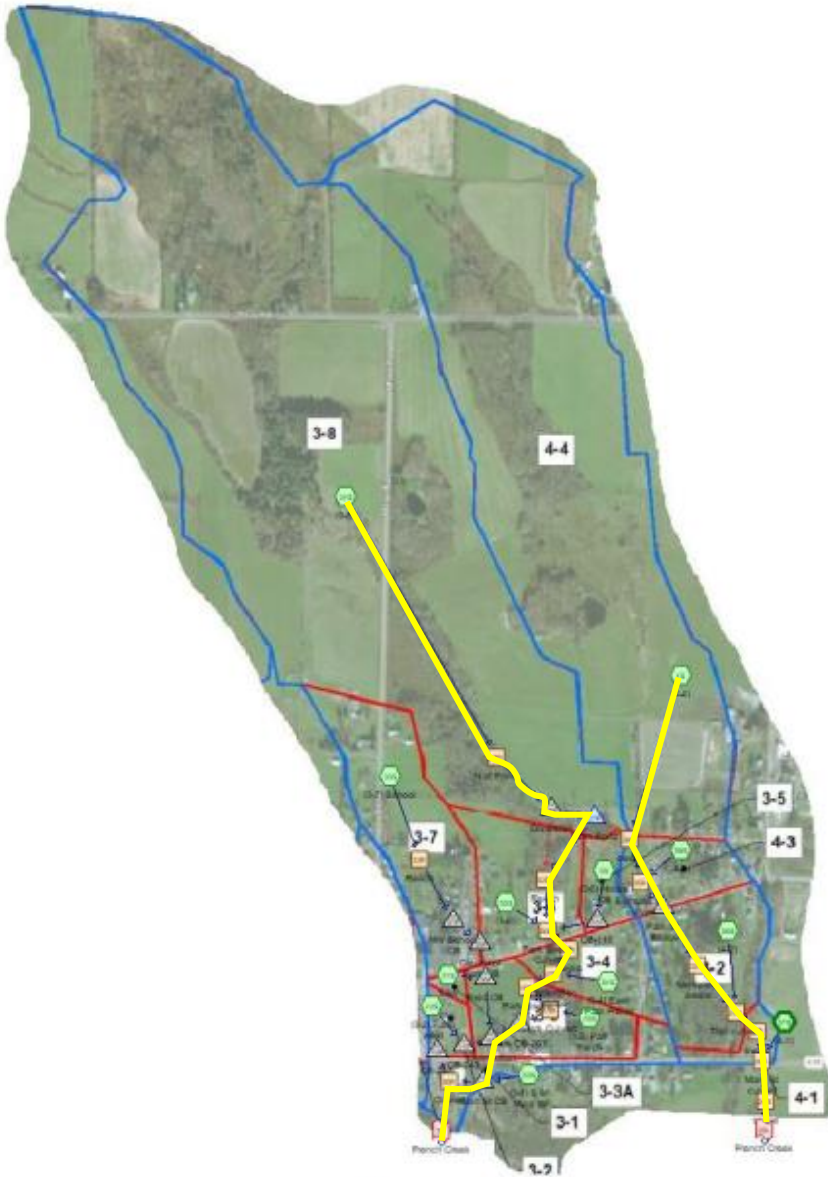
Figure 3-4: DA-3 & DA-4 Model

Table 3-3: DA-3 and DA-4 Peak Flow and Flooding Locations		
Storm Event	Modeled Peak Flow at Outlet (cfs)	Modeled Flooding Location
1-Year Storm	68	<ul style="list-style-type: none"> Within the reach west of Columbia St. north of Sherman High School in residents' backyards Sherman High School athletic fields just southwest of the baseball diamond Sherman High School athletic fields just south of Park St. and east of the faculty lot Within the reach northwest of the Sherman Community Nature Center pond Within a reach north of Sherman Mayville Rd. just east of Chautauqua-Rails-To-Trails

1.5-Year Storm	70	<ul style="list-style-type: none"> No additional flooding areas
2-Year Storm	71	<ul style="list-style-type: none"> No additional flooding areas
10-Year Storm	84	<ul style="list-style-type: none"> Within the reach that borders the Sherman High School athletic fields to the south Within the reach south of Park St. and east of East St. Overtopping the east side of Edmunds St.
25-Year Storm	92	<ul style="list-style-type: none"> Overtopping the west side of Edmunds St. Overtopping south side of E. Main St. Within the reach south of E. Main St. Overtopping west side of Columbia St. just north of the Sherman High School Overtopping CB-118 adjacent to a house north of Park St. Overtopping the intersection of Columbia St. and Park St. Within the reach south of Park St. along the east side of the athletic fields
50-Year Storm	92	<ul style="list-style-type: none"> Overtopping the Sherman Community Nature Center's pond with flow going east from DA-3 to DA-4 Within the reach west of Edmunds St. within DA-4

100-Year Storm	91	<ul style="list-style-type: none"> Overtopping the existing Sherman Community Nature Center pond
500-Year Storm	91	<ul style="list-style-type: none"> Overtopping north side of Park St. upstream of the swale that runs along the athletic fields

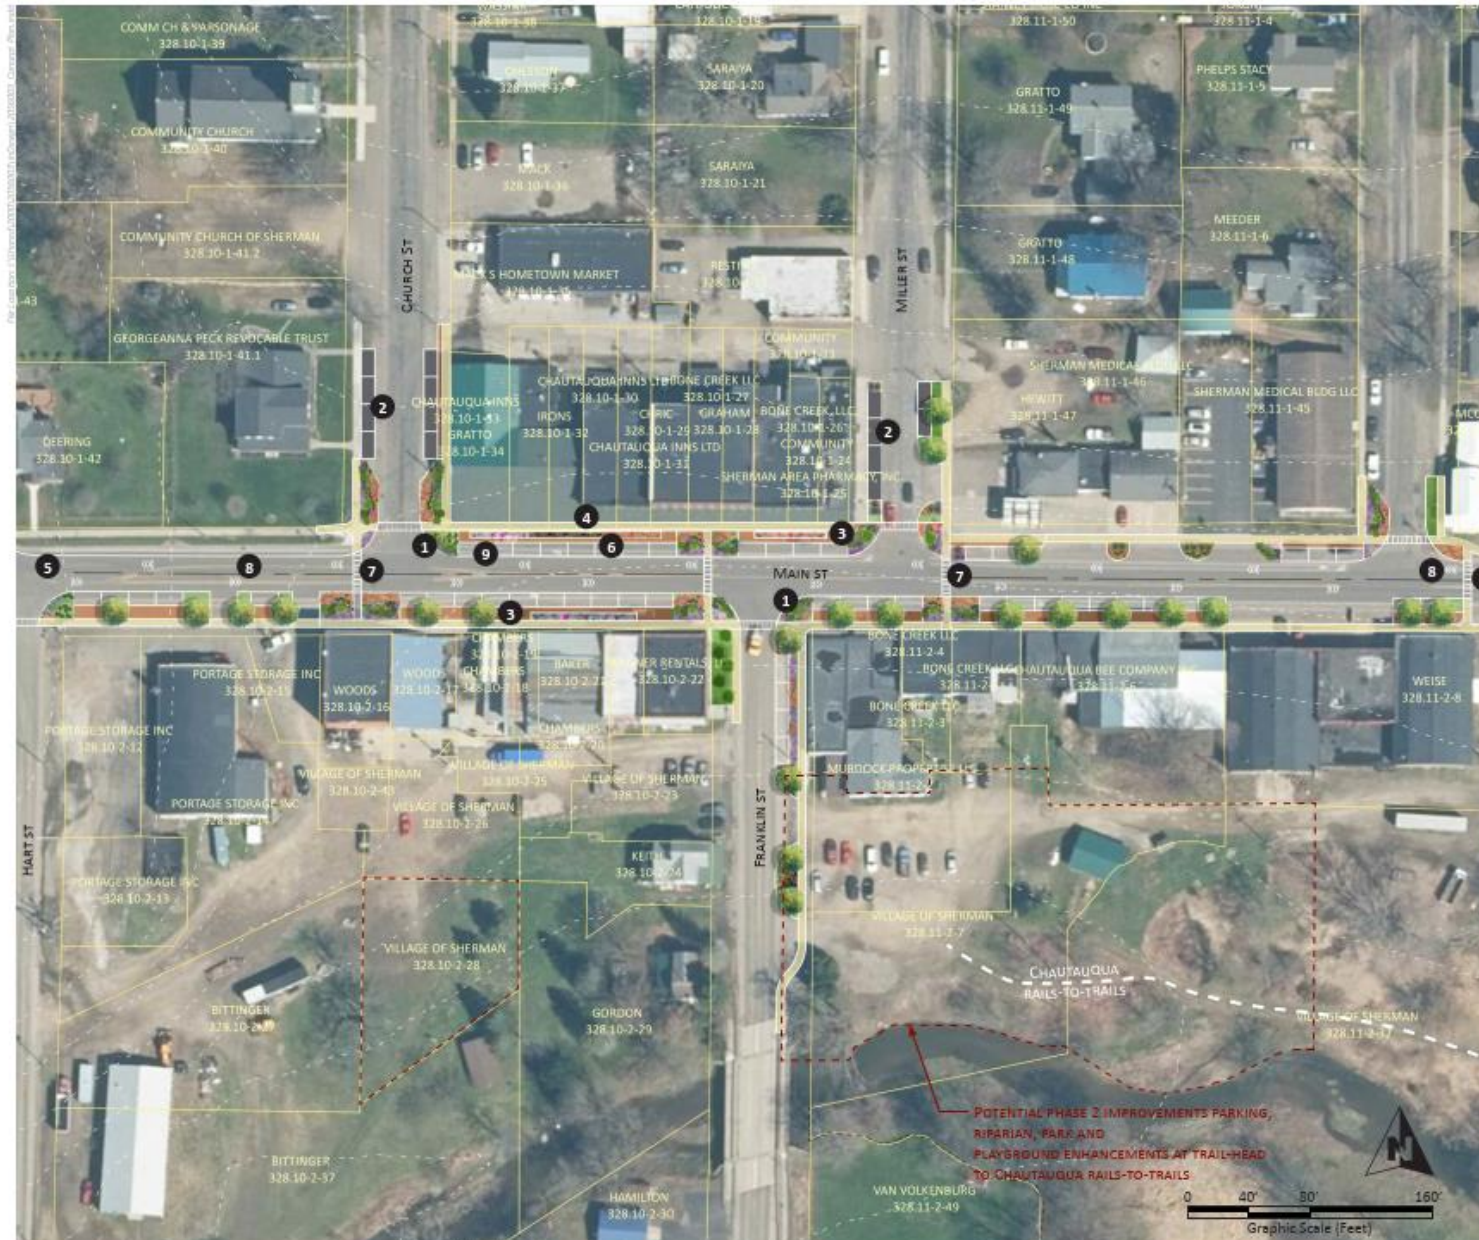
Village of Sherman
Stormwater Infrastructure Preliminary Engineering Report
Project No. 1: Concept Plan
January 2020

- 1 **BIO-RETENTION BUMPOUTS**
Installation of bio-retention bumpouts with curb drops to capture stormwater runoff, for a total coverage of 10,000 SF.
- 2 **PERMEABLE ASPHALT PARKING**
Replacement of existing pavement, for a total coverage of 3,500 SF.

- 3 **FLEXIBLE POROUS PAVEMENT**
Replacement of existing pavement with flexible porous pavement for snow storage and infiltration. Place stormwater street trees with CU structural soil where feasible. 6,500 SF coverage.

- 4 **CONCRETE SIDEWALK**
Concrete sidewalks pitched towards flexible porous pavement for infiltration. Install granite curbing with 6" reveal to direct roadway runoff to curb drops.

- 5 **EASTERN & WESTERN VILLAGE GATEWAYS**
Visually notify the driver that they are entering a dense residential area...and to SLOW DOWN!
- 6 **DOWNSPOUT DISCONNECTIONS**
Installation of rain barrels and stormwater to planters capture and re-use stormwater from downspouts, for a total coverage of 1,060 SF.

- 7 **PEDESTRIAN CROSSINGS**
Enhanced crossings at bumpouts provide traffic calming and pedestrian safety.
- 8 **SHARED LANE MARKINGS**
Install shared lane markings indicating shared space between vehicles and bicyclists.
- 9 **EV CHARGING STATIONS**
Install electric vehicle charging stations at select location (s) for Climate Smart Community certification.

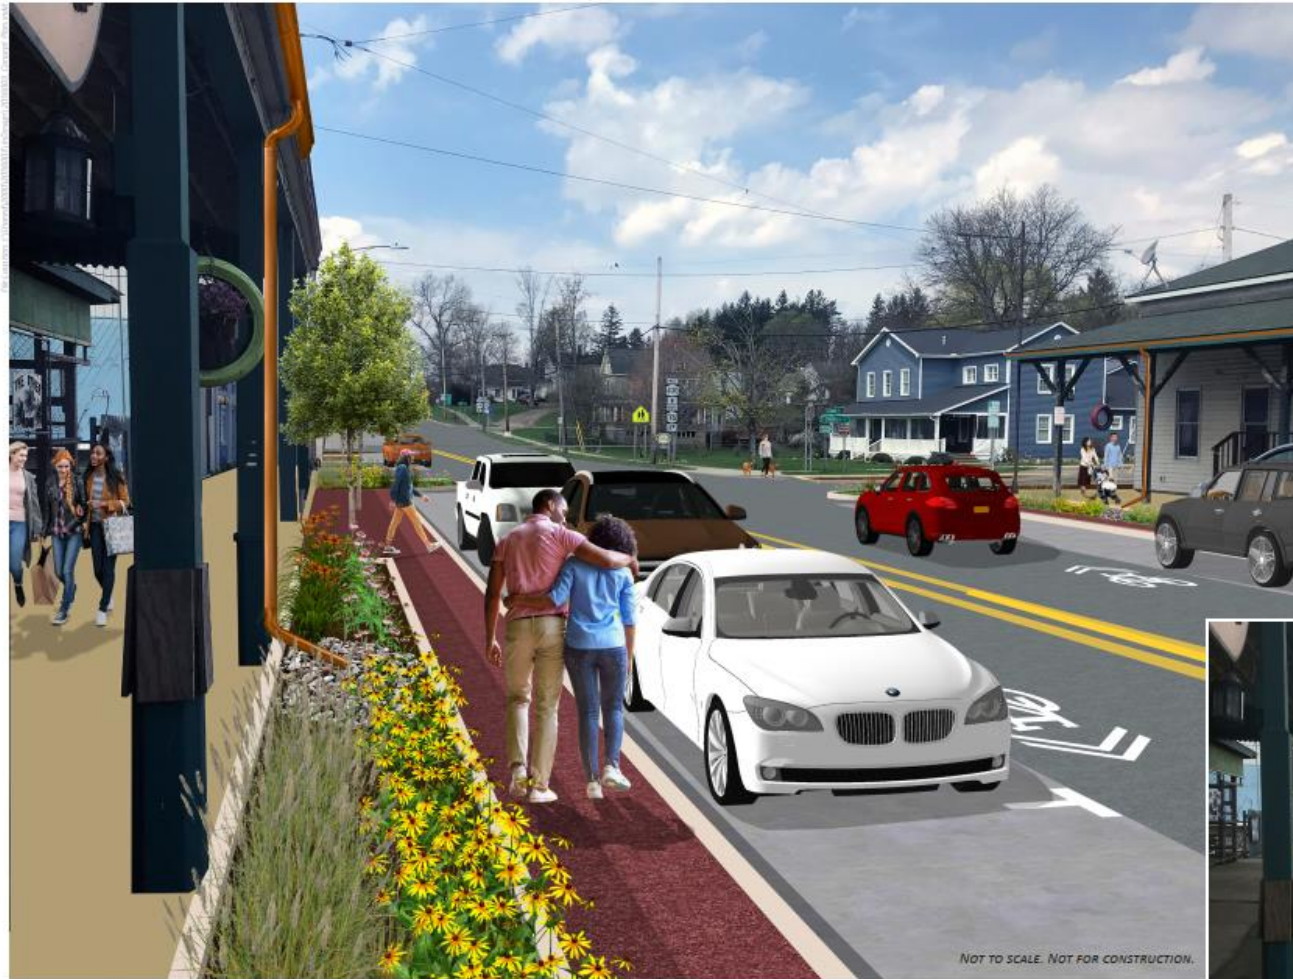
Village of Sherman
Stormwater Infrastructure Preliminary Engineering Report
Project No.1: Perspective on Main Street (view west)
January 2020

PROPOSED CONCEPT SKETCH

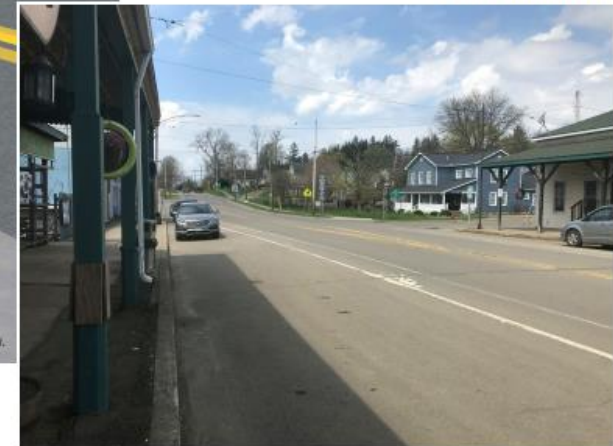
EXISTING CONDITIONS

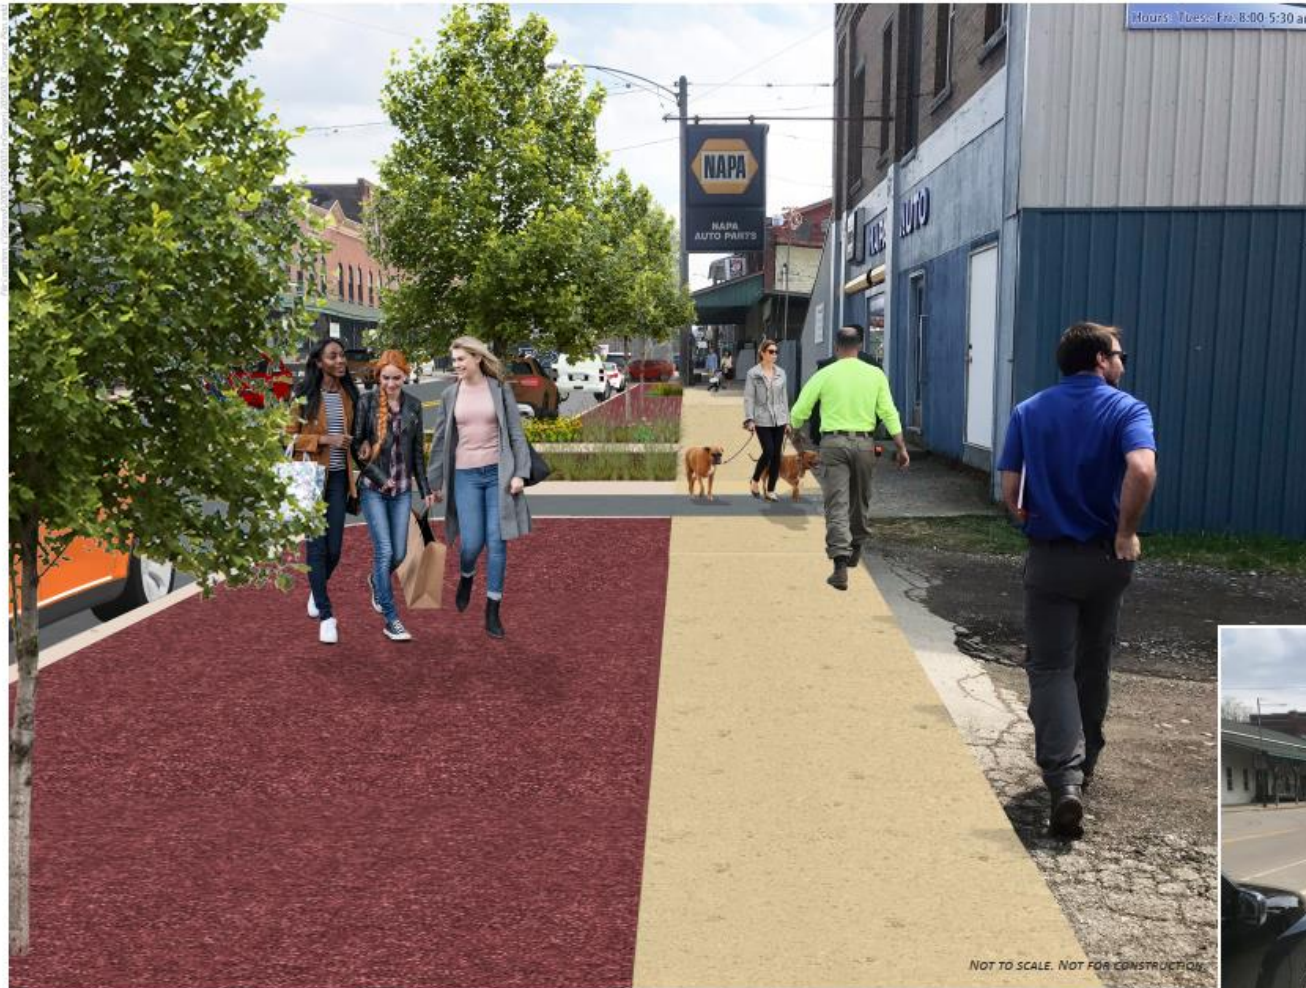
Village of Sherman
Stormwater Infrastructure Preliminary Engineering Report
Project No. 1: Perspective on Main Street (view east)
January 2020

PROPOSED CONCEPT SKETCH

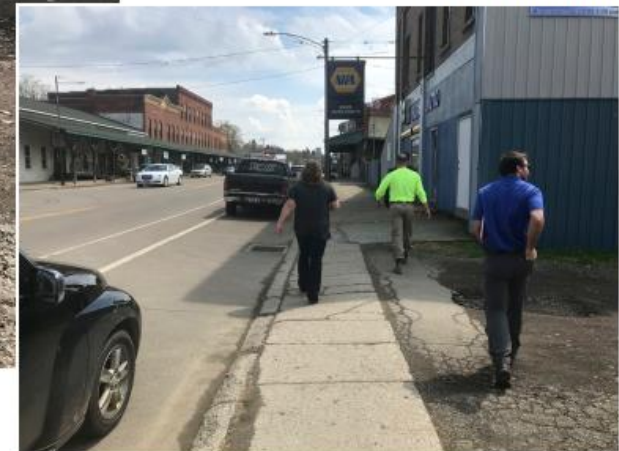
EXISTING CONDITIONS

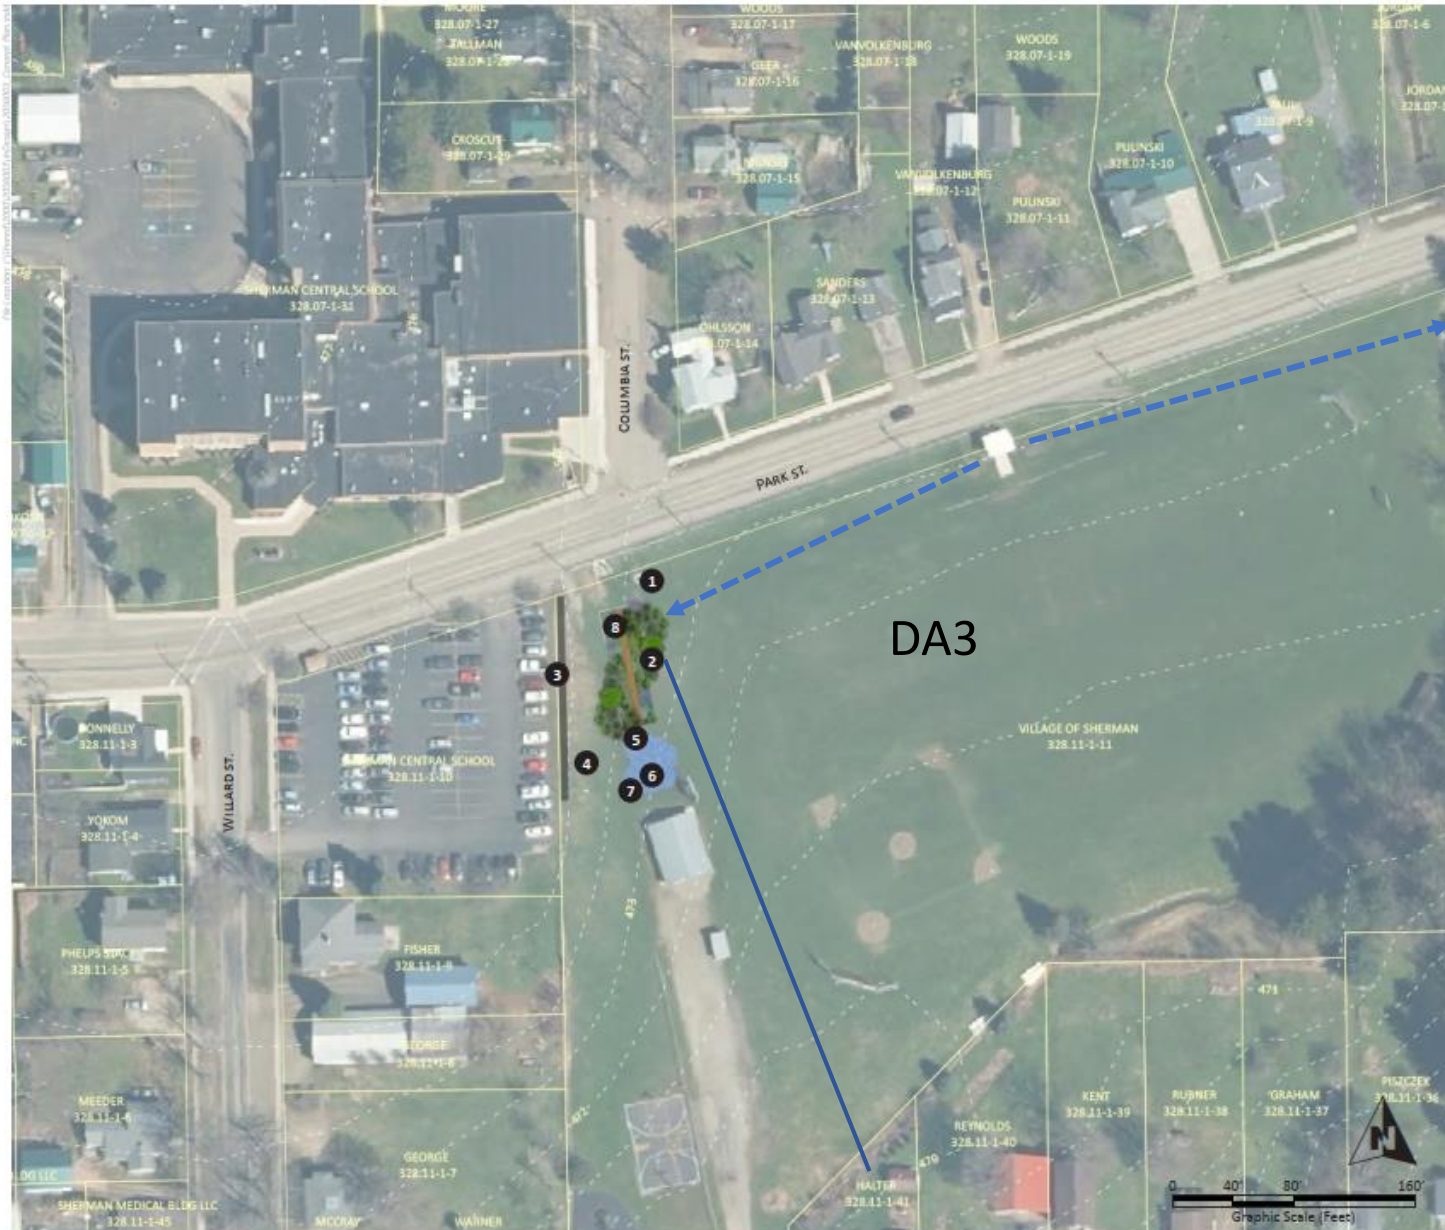
Project No. 2: Concept Plan

- 1 ISOLATION DIVERSION STRUCTURE**
First flush of stormwater runoff directed to offline bio-retention area via isolation diversion structure by modifying the existing catch basin. Higher flows would bypass the offline bio-retention area to stable downstream underground storm drainage to prevent localized flooding.

- 2 BIO-RETENTION AREA**
Minor regrading surrounding area to act as a site low point, for a total coverage of 4,000 SF.
- 3 STONE DIAPHRAGM**
Stone drop (pea gravel diaphragm) provided down-gradient of parking lot for initial treatment of parking lot sheet flow.

- 4 GRASS FILTER STRIP**
Grass filter strip provided down-gradient of stone diaphragm for further pretreatment and to convey flow to the bio-retention area.

- 5 CULVERT/LAND BRIDGE**
Culvert underneath land bridge connecting bio-retention areas to allow pedestrian travel to athletic fields from the adjacent parking lot.

- 6 OVERFLOW/OUTLET**
Overflow/outlet control device that connects to existing underground stormwater infrastructure.
- 7 IMPROVE WATER QUALITY**
Bio-retention vegetation and soils will uptake and filtrate water.

- 8 PROVIDE EDUCATIONAL & AESTHETIC VALUE**
Interpretive panels along a wooden pedestrian bridge providing information about the bio-retention area, ecology, and its associated watershed would be located along the bio-retention area to simulate educational opportunities.

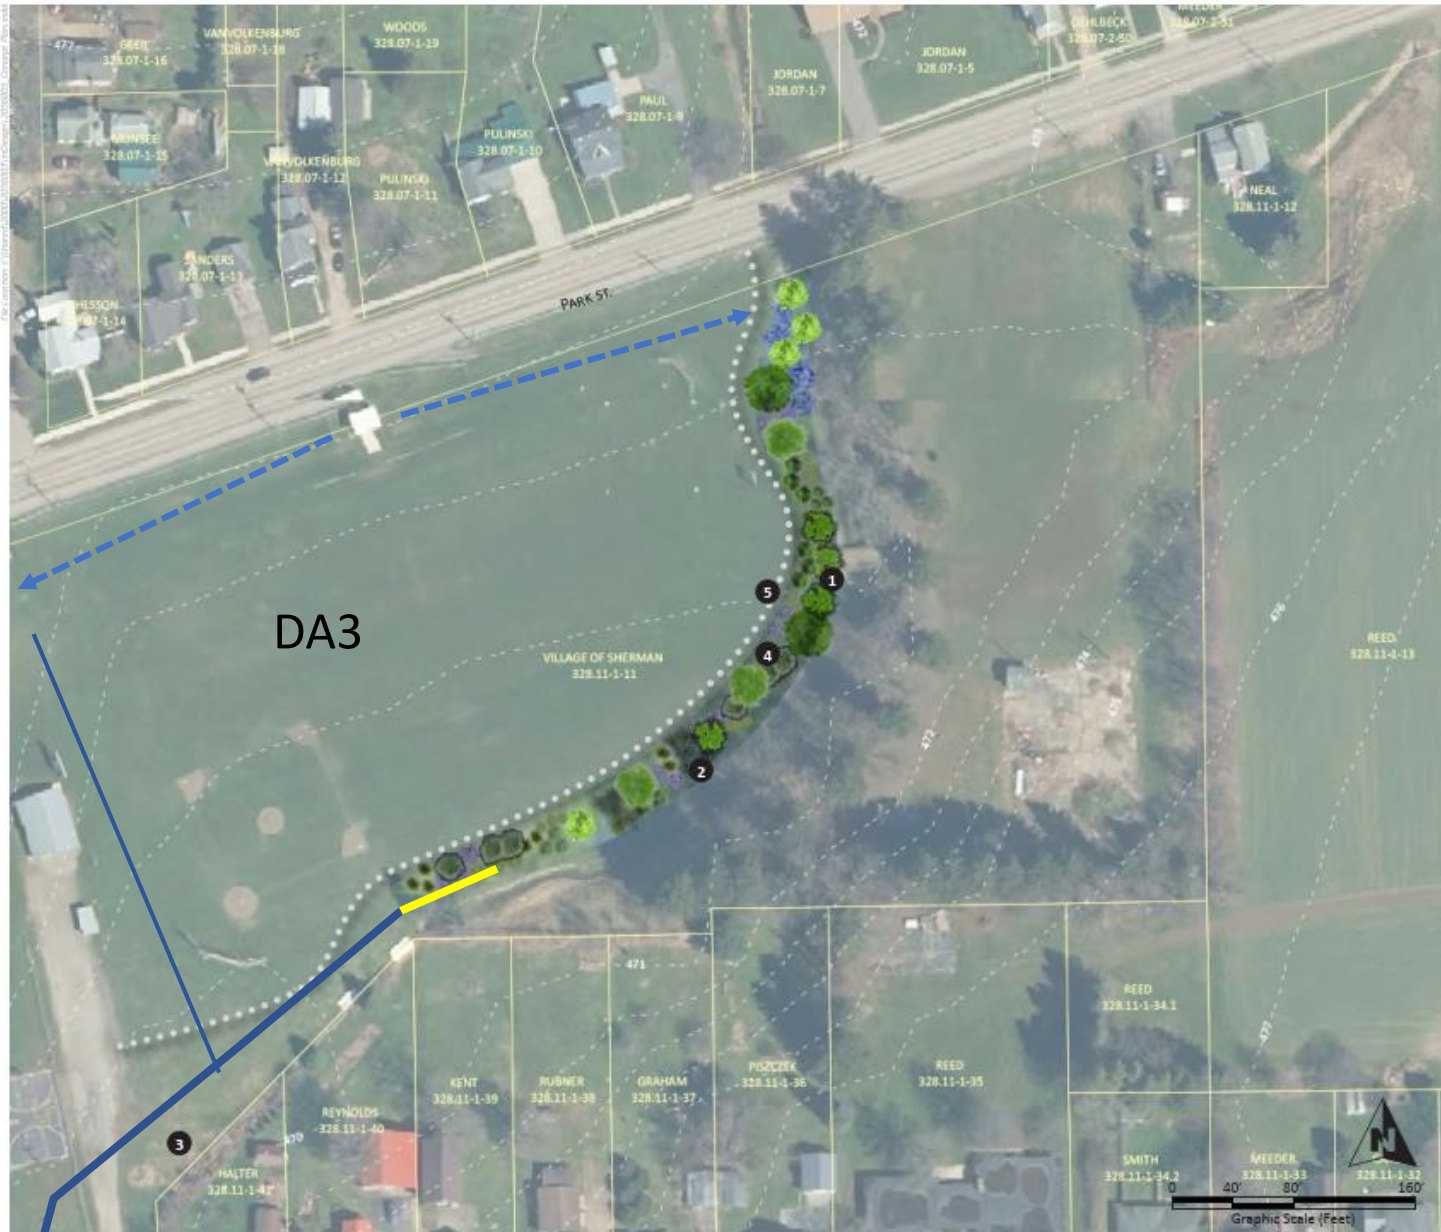
Village of Sherman
Stormwater Infrastructure Preliminary Engineering Report
Project No. 3: Concept Plan
January 2020

- 1 **RIPARIAN BUFFER**
Riparian buffer ranging from 25'-50' Perpendicular to stream that filters athletic field runoff. Riparian vegetation would aid in lowering groundwater table via water uptake.
- 2 **HABITAT**
Riparian vegetation shading the stream to optimize light and temperature conditions for aquatic animals.
- 3 **FLOOD REDUCTION**
Riparian vegetation slows upstream sheet flow reducing downstream flooding via infiltration and energy dissipation.
- 4 **AESTHETIC VALUE**
Diverse vegetation provides scenic value to nearby recreational fields, and provide a physical barrier from the stream.
- 5 **SHARED-USE PATH**
10-foot wide stone dust path for pedestrians and park maintenance vehicles.

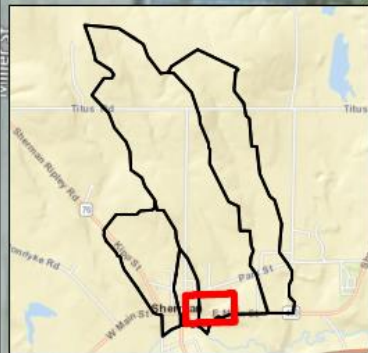
OVERFLOW PIPE FROM BIORETENTION AREA

**~40'
36" PIPE
EXTENSION**

Model Name: 'CB-243'
Size: 48 inches
Length: 30.4 feet
Inlet Invert: 1,536.36
Outlet Invert: 1,537.34
Slope: -0.0322

Model Name: 'Park Culvert'
Size: 36 inches
Length: 218.2 feet
Inlet Invert: 1,540.16
Outlet Invert: 1,538.19
Slope: 0.0090

Model Name: 'CB-203'
Size: 36 inches
Length: 32.4 feet
Inlet Invert: 1,538.18
Outlet Invert: 1,538.0
Slope: 0.0059

Model Name: 'Connection'
Size: 36 inches
Length: 172.0 feet
Inlet Invert: 1,538.0
Outlet Invert: 1,537.06
Slope: 0.0055

*RECOMMEND INCREASING TO 48"

Model Name: 'CB-247'
Size: 3 feet x 4 feet
Length: 51.9 feet
Inlet Invert Elevation: 1,537.34
Outlet Invert Elevation: 1,536.81
Slope: 0.0102

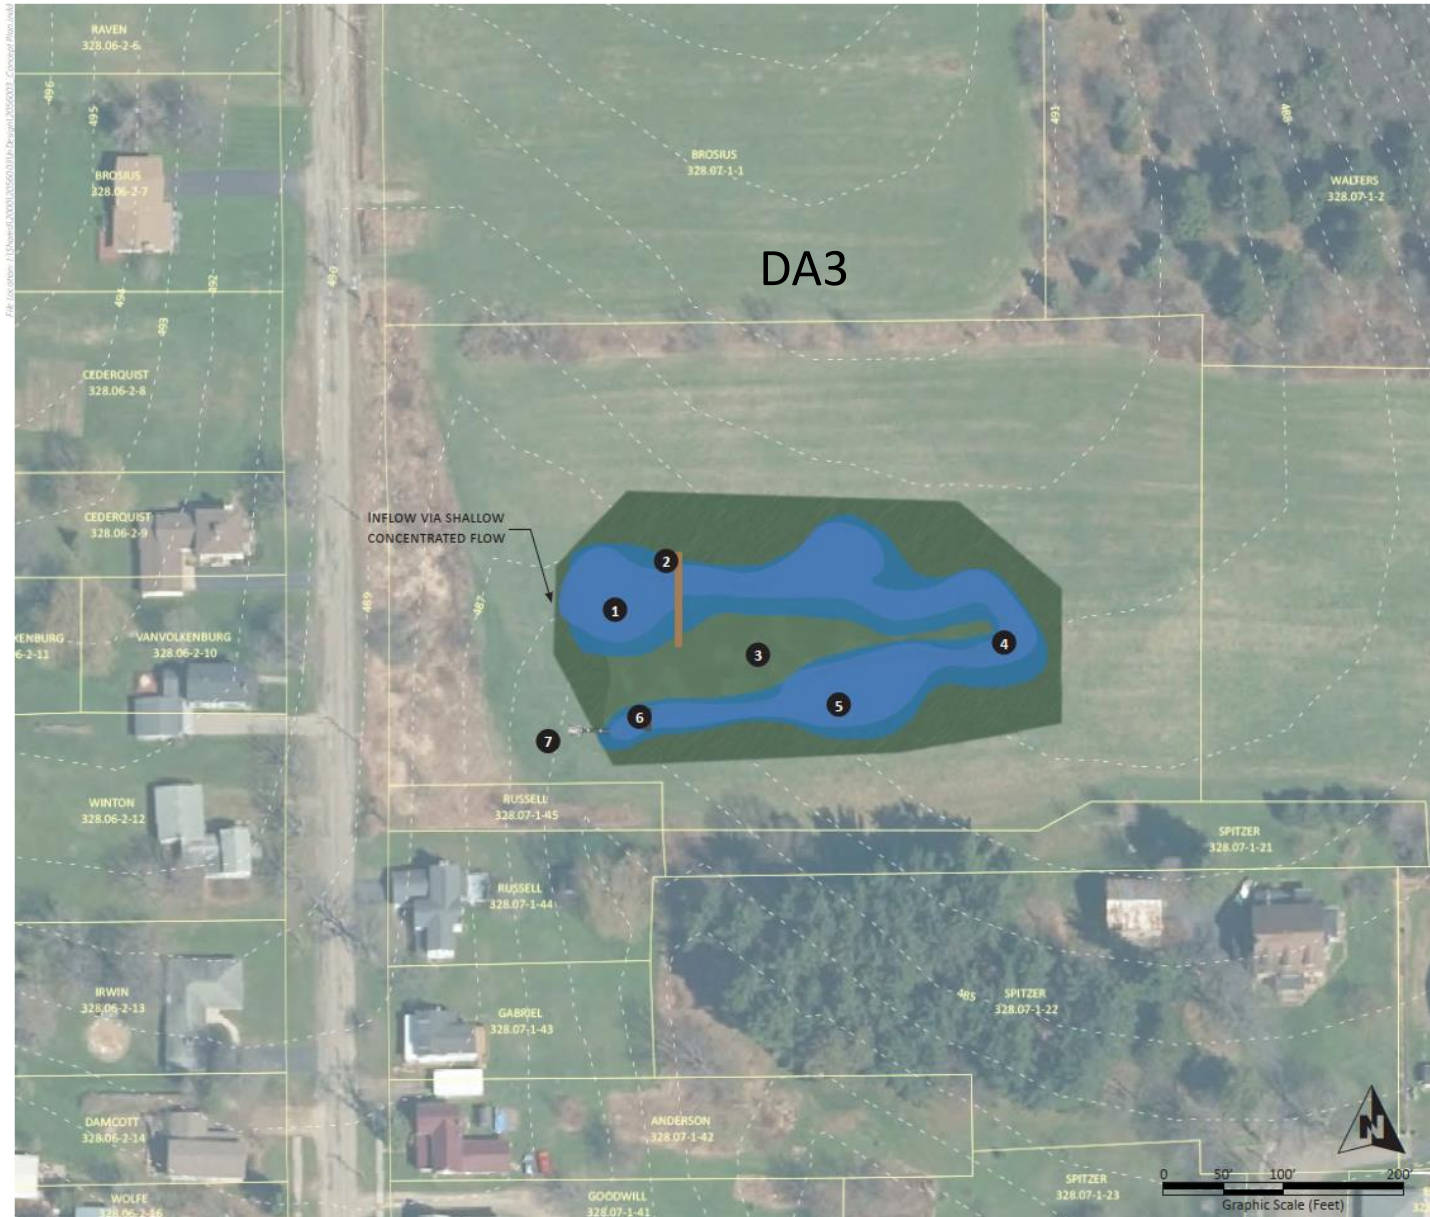
Village of Sherman
Stormwater Infrastructure Preliminary Engineering Report
Project No. 6: Concept Plan
January 2020

- 1 **FOREBAY**
Pretreatment approximately 4' to 6' deep and stores approximately 10% of the water quality volume to protect the flow pipe from clogging and prevent sediment resuspension.

- 2 **FOREBAY SPILLWAY**
Overflow designed to allow water from forebay to flow into high marsh bordered by vegetated berm where water infiltrates.
- 3 **HIGH MARSH**
Internal berm to provide a minimum flow path of 2:1 (length to relative width) heavily vegetated with a variety of native plants. During large storm events, the high berm is inundated and approximately 0.5' deep.

- 4 **LOW MARSH**
Provides a low flow channel and is typically inundated (approximately 1.5' deep).
- 5 **MICRO-POOL**
A smaller permanent pool to avoid resuspension or settling of particles, provide habitat for aquatic plants and animals, and is approximately 7' deep).

- 6 **EMERGENCY SPILLWAY**
Emergency spillway at 1570.0' designed for flow release during 10-year storms or greater.
- 7 **OUTFALL**
Outlet to existing shallow concentrated flow path.

- 8 **REDUCE PEAK STORM FLOWS**
Provide water quantity storage and detention to reduce flooding in downstream areas including the lots between Miller St. and Columbia St. by preventing localized flooding from a 1-year storm.

- 9 **HABITAT DIVERSITY**
Provide habitat for waterfowl and other wetland species through selection of native wetland plantings.
- 10 **ENHANCE WATER QUALITY**
Provide off-line water quality treatment storage from the contributing drainage area via pollutant settling and biological uptake.

Impacts of Projects 4, 5, and 6 Detention ponds

Drainage Area	1-Year Storm Event		1.5-Year Storm Event		2-Year Storm Event		10-Year Storm Event	
	Existing Condition (cfs)	Proposed Condition (cfs)	Existing Condition (cfs)	Proposed Condition (cfs)	Existing Condition (cfs)	Proposed Condition (cfs)	Existing Condition (cfs)	Proposed Condition (cfs)
DA-1	59	16	59	19	60	22	71	44
DA-2	10	10	13	13	15	15	33	33
DA-3	65	41	67	49	68	57	82	61
DA-4	3	3	3	3	3	3	3	3
Drainage Area	25-Year Storm Event		50-Year Storm Event		100-Year Storm Event		500-Year Storm Event	
	Existing Condition (cfs)	Proposed Condition (cfs)	Existing Condition (cfs)	Proposed Condition (cfs)	Existing Condition (cfs)	Proposed Condition (cfs)	Existing Condition (cfs)	Proposed Condition (cfs)
DA-1	78	62	85	77	94	93	123	123
DA-2	49	49	63	63	81	81	138	138
DA-3	89	68	89	81	88	87	88	87
DA-4	3	3	3	3	3	3	3	3
