Comprehensive Water Assessment Study

Village of Sherman, Chautauqua County, New York

Preliminary Engineering Report

August 2019

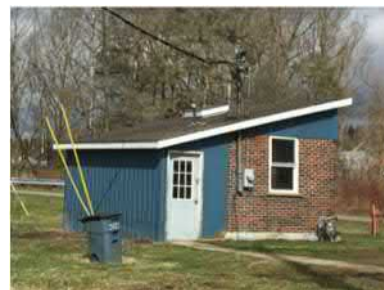
Well House No. 1

The output of each well pump is individually metered inside each well house. The water meters are antiquated and need in of replacement. The exposed well pump discharge piping and valves for both Well No. 1 and No. 2 are displaying significant signs of corrosion and deterioration likely as a result of the sodium hypochlorite being

located in close proximity to the piping. The CCDOH has issued a violation for the condition of both well houses interior piping, meters, and valves stating they require complete replacement and citing NYSDOH Subpart 5-1.71b as basis for this violation.

The Village Water System has two (2) different Well Buildings (Houses), one for Well No. 1 and one Well No. 2. Well Building No. 1 is a brick framed building with a small wood framed addition used for storage. Overall, Well Building No. 1 is in structurally sound condition, but does require various minor improvements including new pipe gallery grating, removal of abandoned control panels, and various general cosmetic updates and improvements.

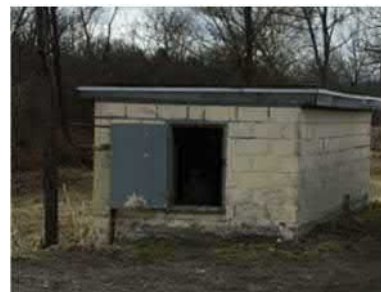
Well House No. 2

Well Building No. 2 is a CMU structure half buried below grade and was found to be overall in poor condition. The only access to the well building is through a small “half” door which leads down onto a wobbly wooden step platform. Entering this Well Building is a safety hazard. The Well Building is extremely poorly lit and only kept dry through the use of a sump pump that is located in small open hole cut into the well house floor. The CCDOH issued a violation for the condition of this well house stating it should be replaced in its entirety and again citing NYSDOH Subpart 5-1.71b as basis for the violation.

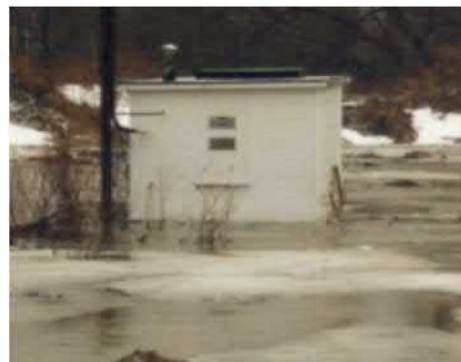
Historic Photo of Flooding Around Well House No. 2

Operators state that the concrete pedestals which support the pump motor in both Well House No.1 and No. 2 have never been flooded over as they are elevated just above the highest experienced flood waters. However, with climate change and the regular occurrence of 100 year storms, both wells are at significant risk of being contaminated by surface water during flooding events which is a major health violation.

Current code and design practices require critical infrastructure to be protected from flooding by being located 3-feet above the 100 year flood plain, which Sherman's infrastructure is not. With the impacts of climate change and the increased frequency of severe weather events, the current constructed elevations of Well House No. 2 combined with lack of flood protection is a major issue for the Village. The CCDOH has issued a violation for pumping facilities located in flood plain citing NYSDOH Subpart 5-1.71b and NYSDOH Subpart 5-1 Appendix A, Section 8.2.1 and Section 6.1.1 as a basis for the violation.

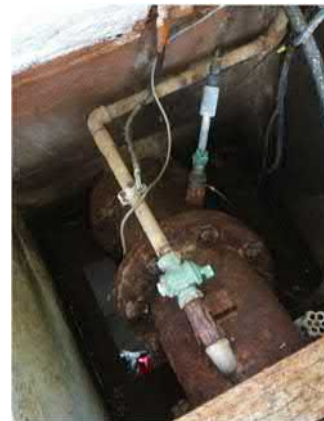
Inoperable Injection Quill

Currently, the chlorine injection quill in Well House No.1 is deteriorated and inoperable. The Village operators do not have the tools or equipment to replace this injection quill internally without shutting down nearly the entire water system for several hours. Without a working chlorine injection quill in Well House No. 1, water from Well No. 1 cannot be treated with chlorine as it exits the Well House. Operators are forced to only operate Well No. 1 when Well No. 2 is running. Water from Well No. 2 is over chlorinated and blended with the unchlorinated Well No. 1 water in the transmission piping to ensure proper chlorine residuals are achieved. Should Well No. 2 or its chlorination system become inoperable, the Village will have no method of disinfection and be forced to be placed on a Boil Water Order. The current practice of disinfecting water from Well No. 1 has been deemed unacceptable by the CCDOH and a violation by the CCDOH was issued as a result. The CCDOH cited NYSDOH Subpart 5-1.30 as a basis for the violation.

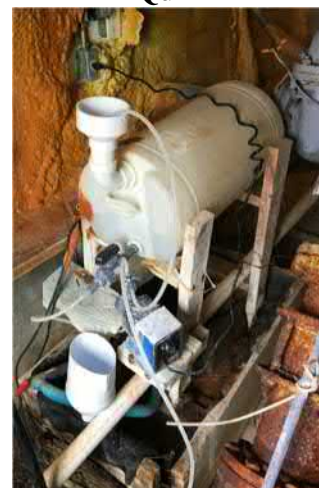
Chlorine Set-Up Well No. 2

The Village utilizes liquid sodium hypochlorite (chlorine) to disinfect their drinking water. Each well house contains a day tank of liquid sodium hypochlorite and a chemical feed pump which doses the well water as it exits the well house through an injection quill. The existing chemical disinfection equipment is reaching the end of their useful lives and is in need replacement. The chlorine containment setup is less than ideal as it consists of an old drum that was cut in half and mounted into a wooden frame. Additionally, neither well house has a proper isolated chemical room. Chlorine fumes have caused significant deteriorating of nearby exposed ductile/cast iron piping and valving.

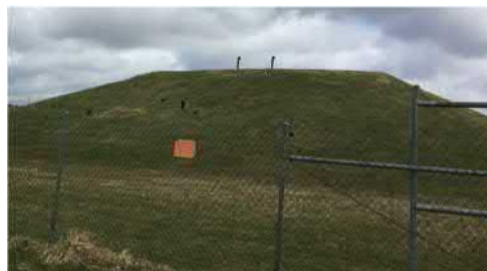
Water Storage Tank

The Village of Sherman currently has one (1) ground water storage tank that provides water storage and pressurizes the Sherman Water System. The tank is located on the North side of the village off of Miller Street. The storage tank is a 300,000 gallon cast-in-

place concrete rectangular storage tank. The rectangular tank has a concrete wall running down the center of it, effectively splitting it down the middle into two (2) 150,000 gallon sections. This allows the water operator to take each half of the tank down separately for inspection, maintenance, and cleaning. The storage tank is mostly buried with dirt and grass to protect it from freezing. Design details of the water tank are summarized in Table 3-2 below.

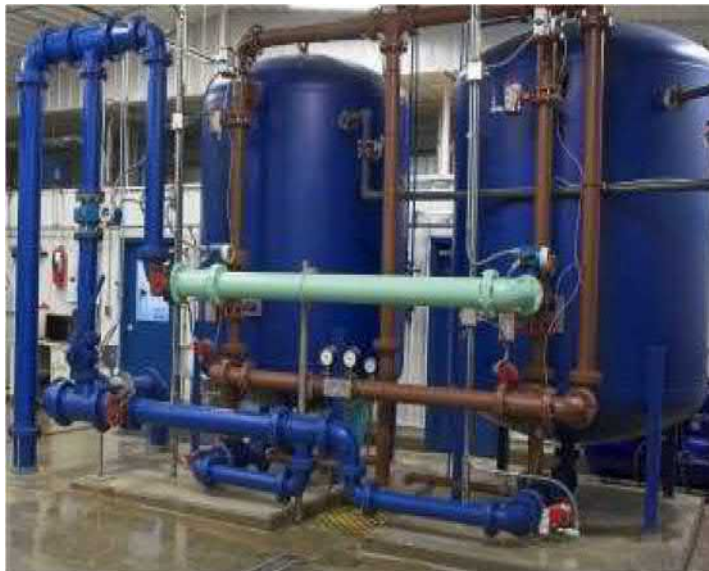
Ion Exchange Water Softening System

The water softener equipment would consist of two (2) pressure vessels mounted on a skid and house in a building. It is anticipated that should the Village decide to move forward with a softening process, the softening building would be combined with a water chlorination/treatment as described later in this report. The water softening pressure vessels would backwash into a concrete backwash tank which

would be drained at a slower, controlled rate into the sanitary sewer system. A preliminary floor plan of treatment building that would include water softening equipment is shown in Figure 4.

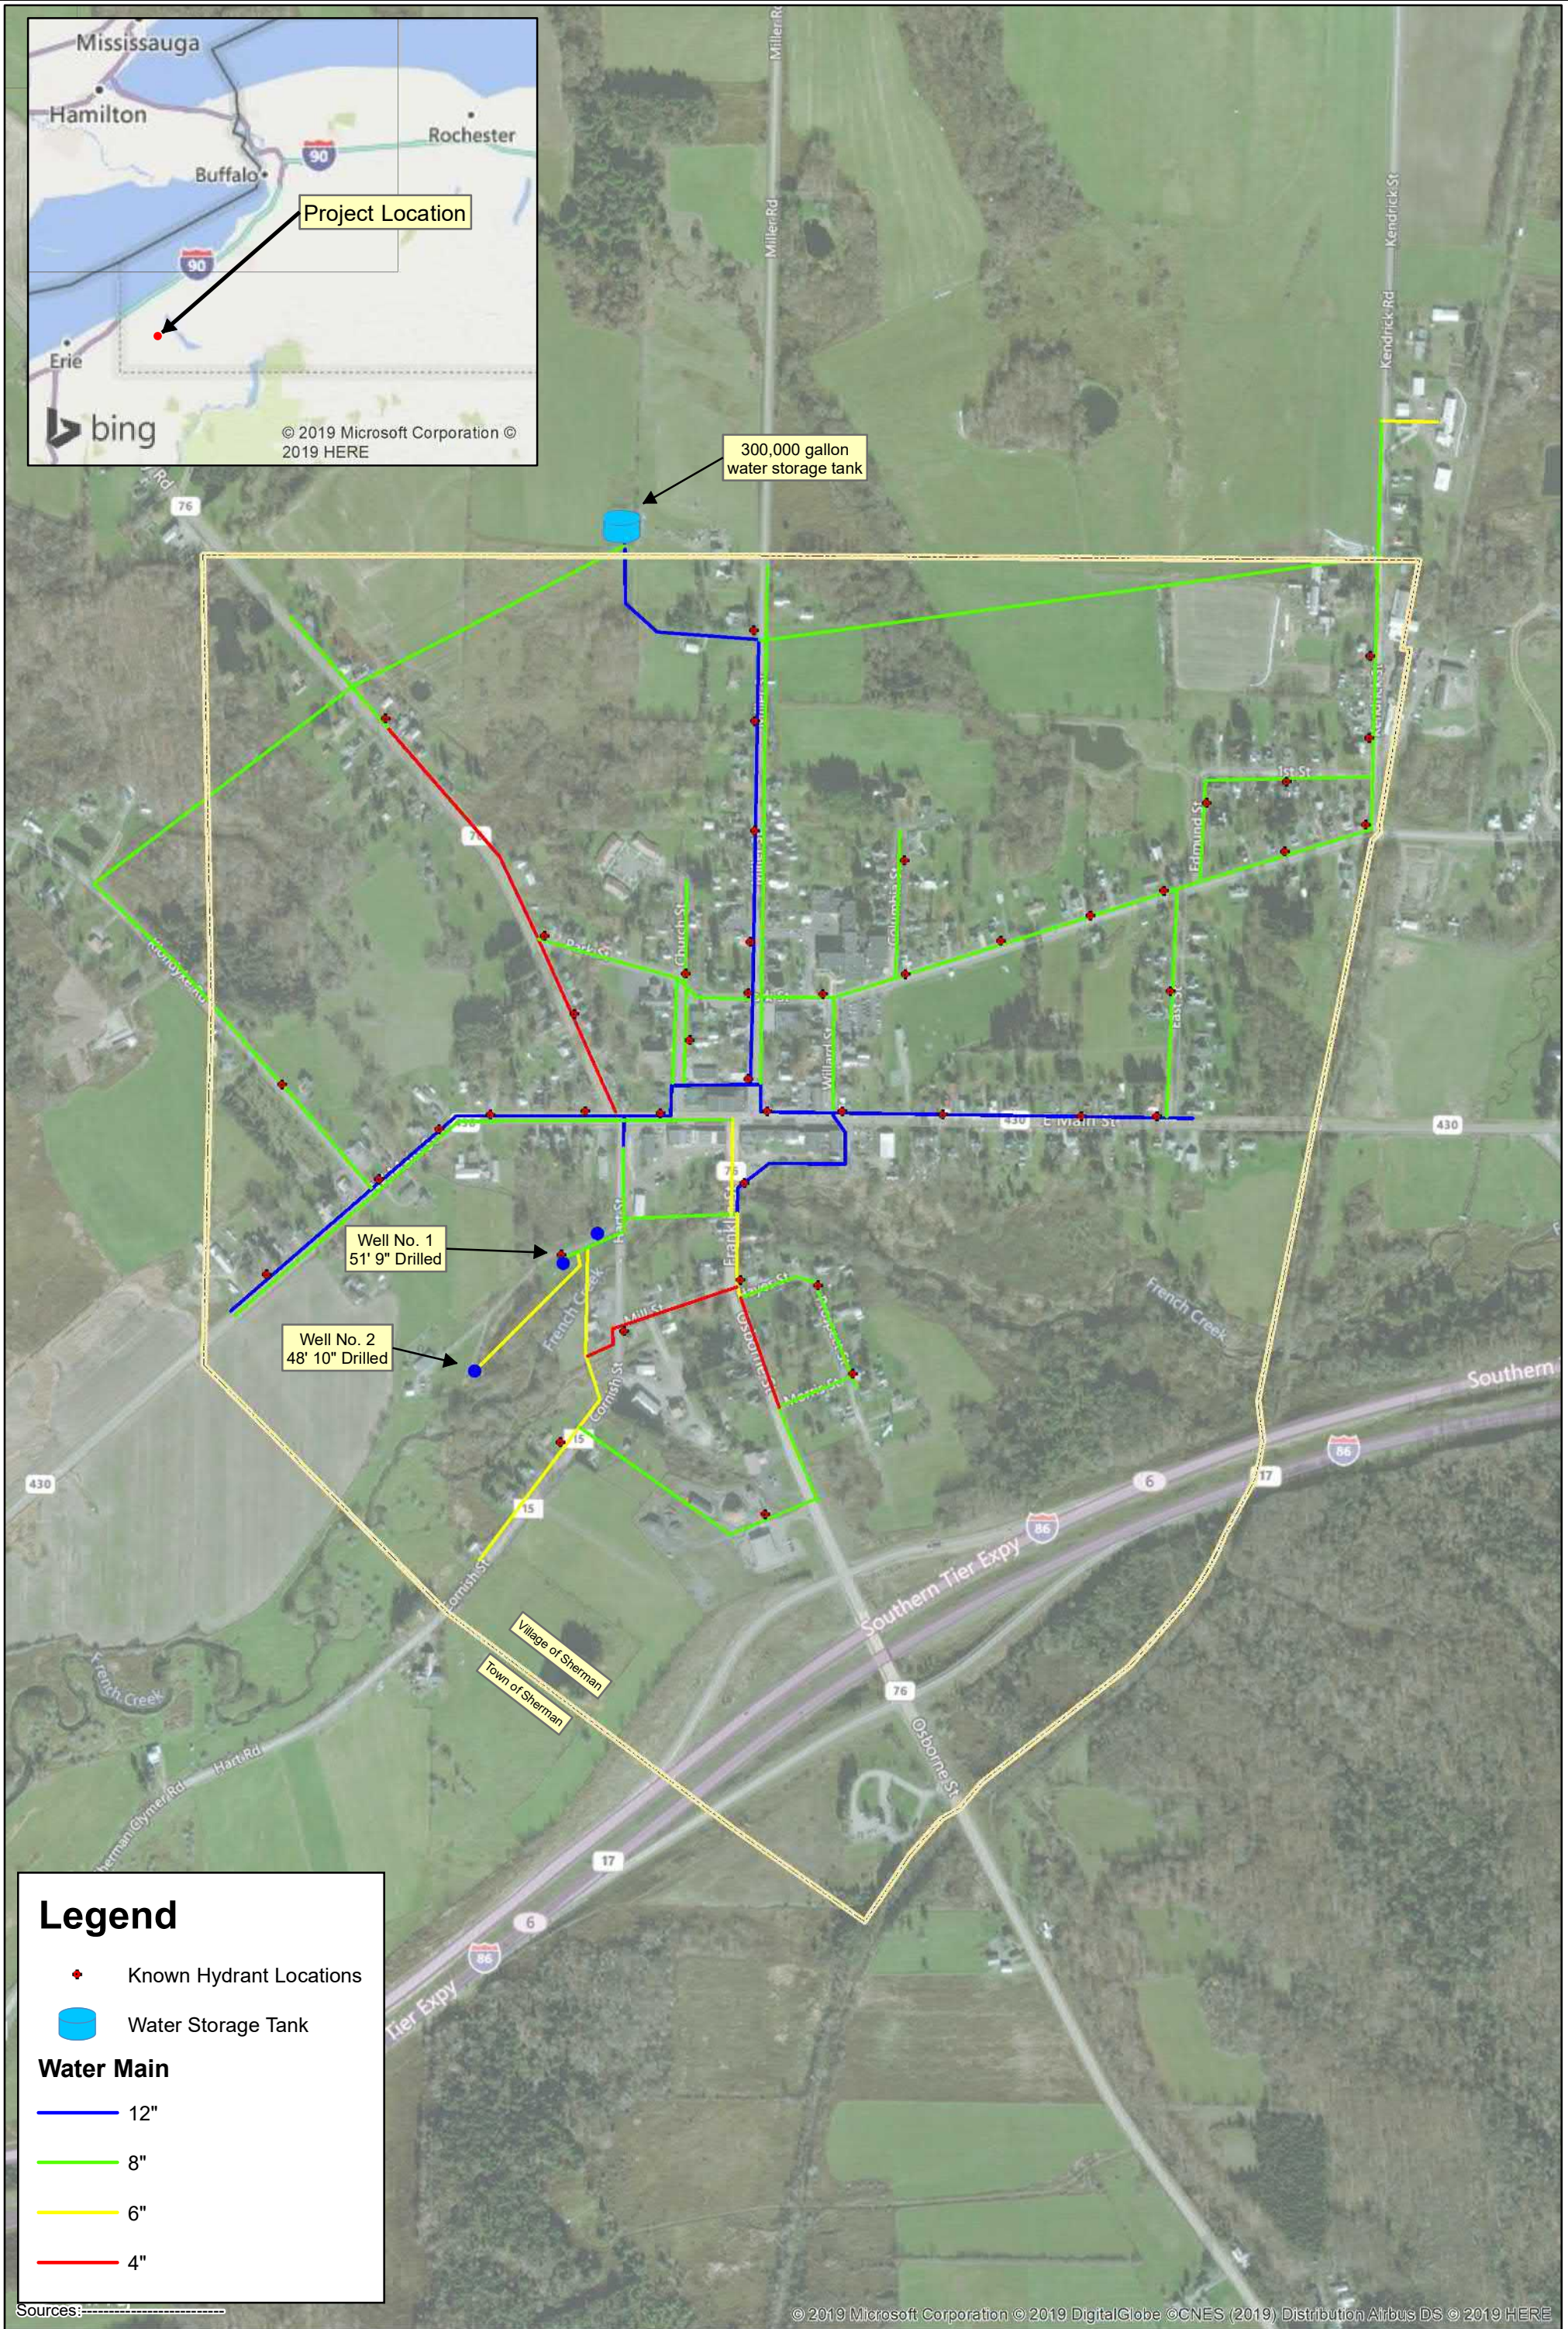
Figure 1

The Village Sherman water system (shown in Figure 1) dates back to the early 1800s and contains approximately 8,700 feet of 12-inch piping, 26,800 feet of 8-inch piping, 3,300 feet of 6-inch piping, and 3,300 feet of 4-inch piping. In the last 15 years, operators have installed a significant amount of new water distribution main to replace antiquated or undersized main that has reached the end of their useful lives; however, there are still several sections of main that require replacement. Although, operators have installed several miles of new ductile iron water main in the Village, much of the old antiquated water main is still active and has not been decommissioned. In several cases, this is a result of long side services being still connected to the antiquated water main. This is believed to be a major contributing factor to the Village's 48% water loss rate. Known deficiencies of water distribution and transmission piping are listed below:

Existing Water System Map

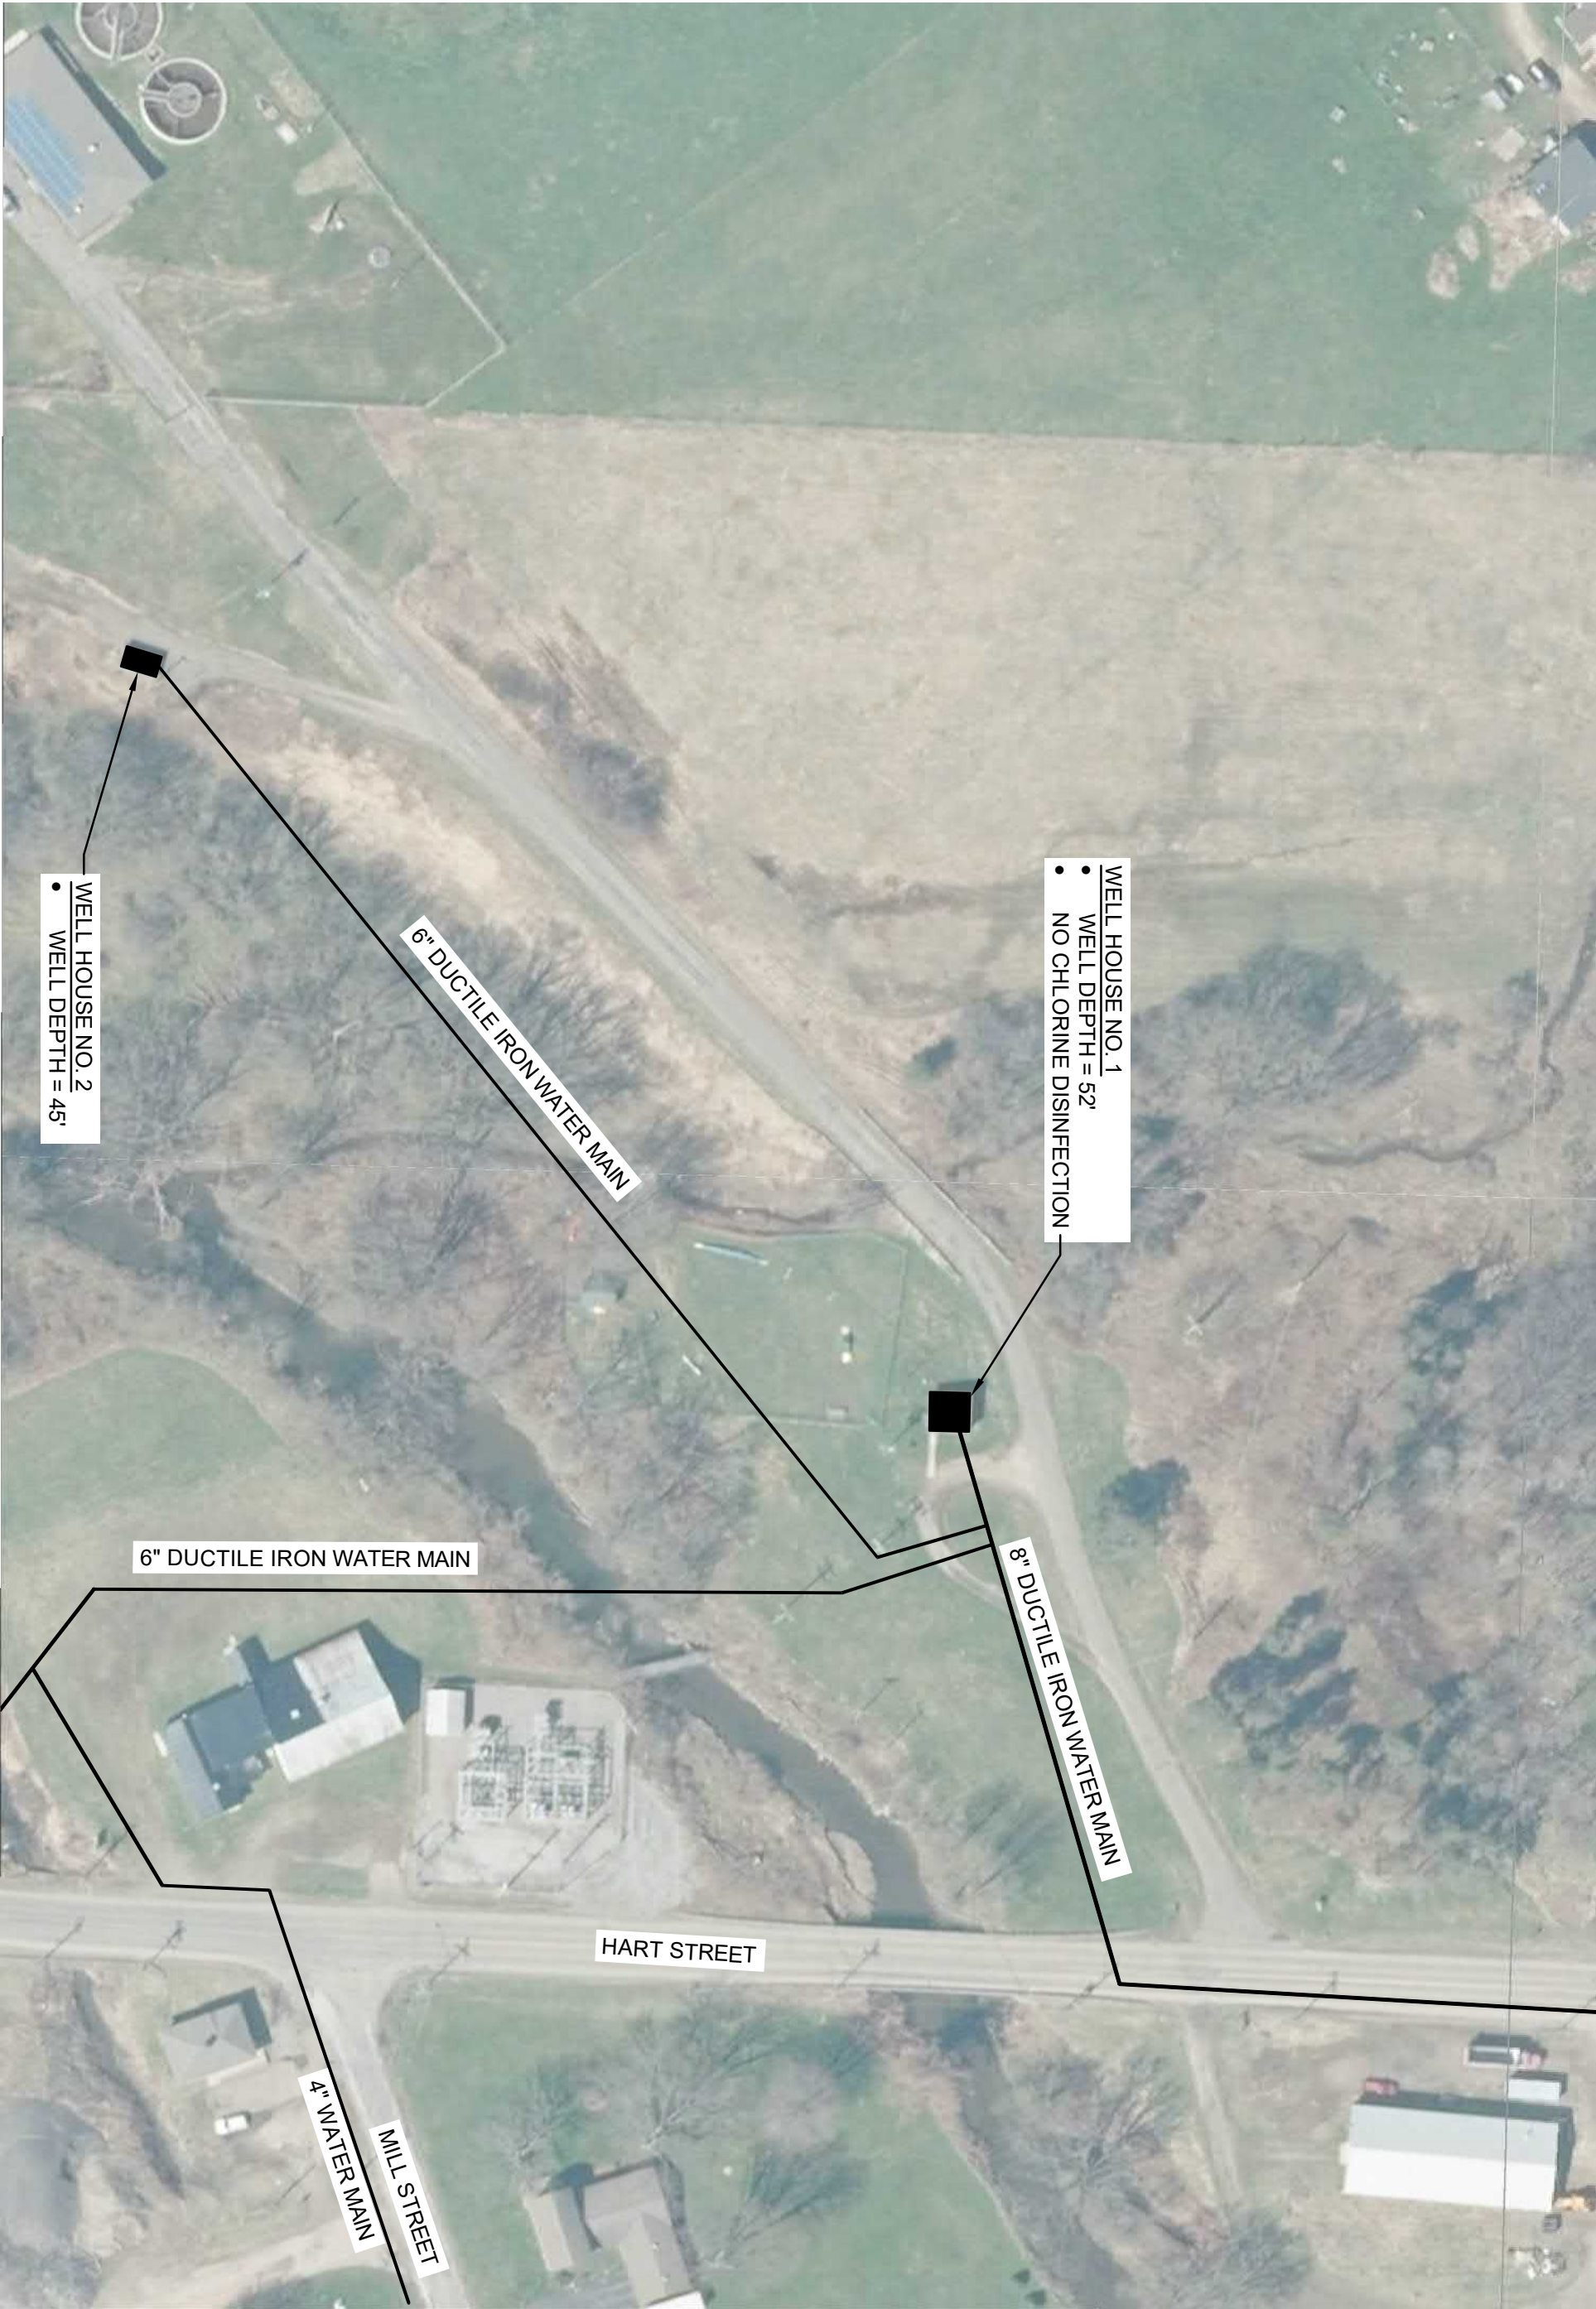
Figure 2

Existing Well Site Layout

WELL HOUSE NO. 1
• WELL DEPTH = 52'
• NO CHLORINE DISINFECTION

WELL HOUSE NO. 2
• WELL DEPTH = 45'

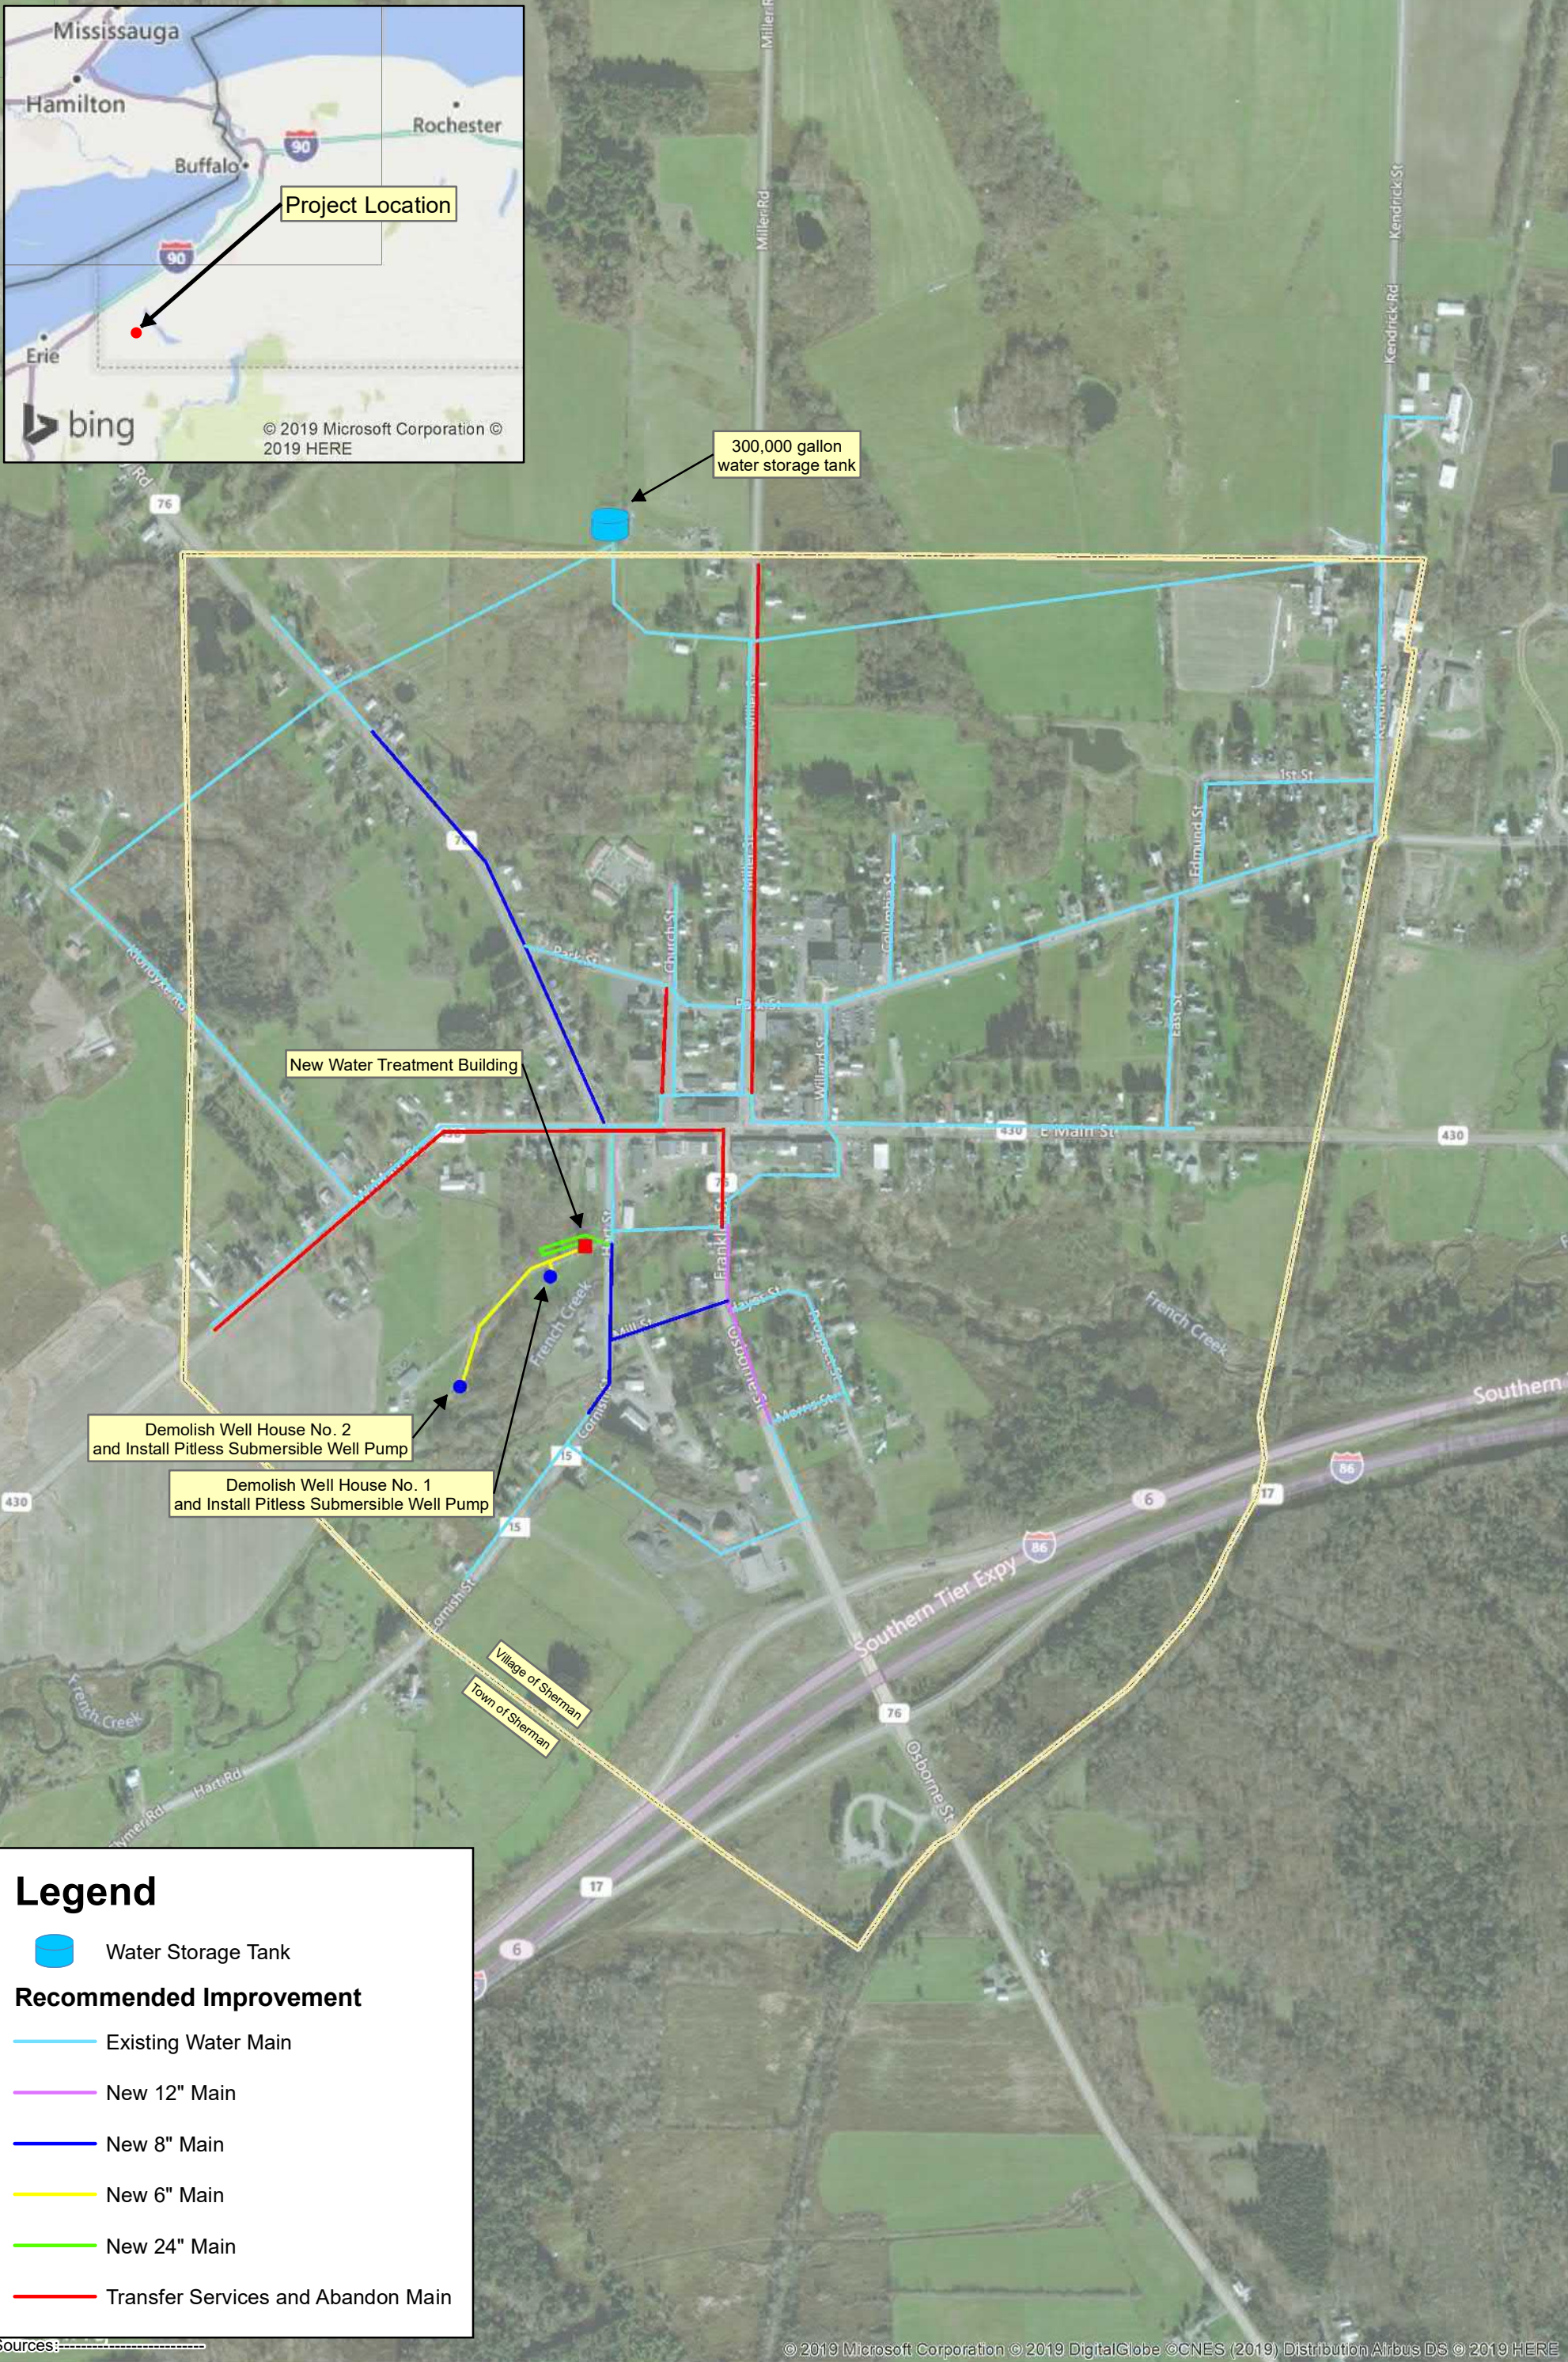
Figure 3

Recommended Improvements Map

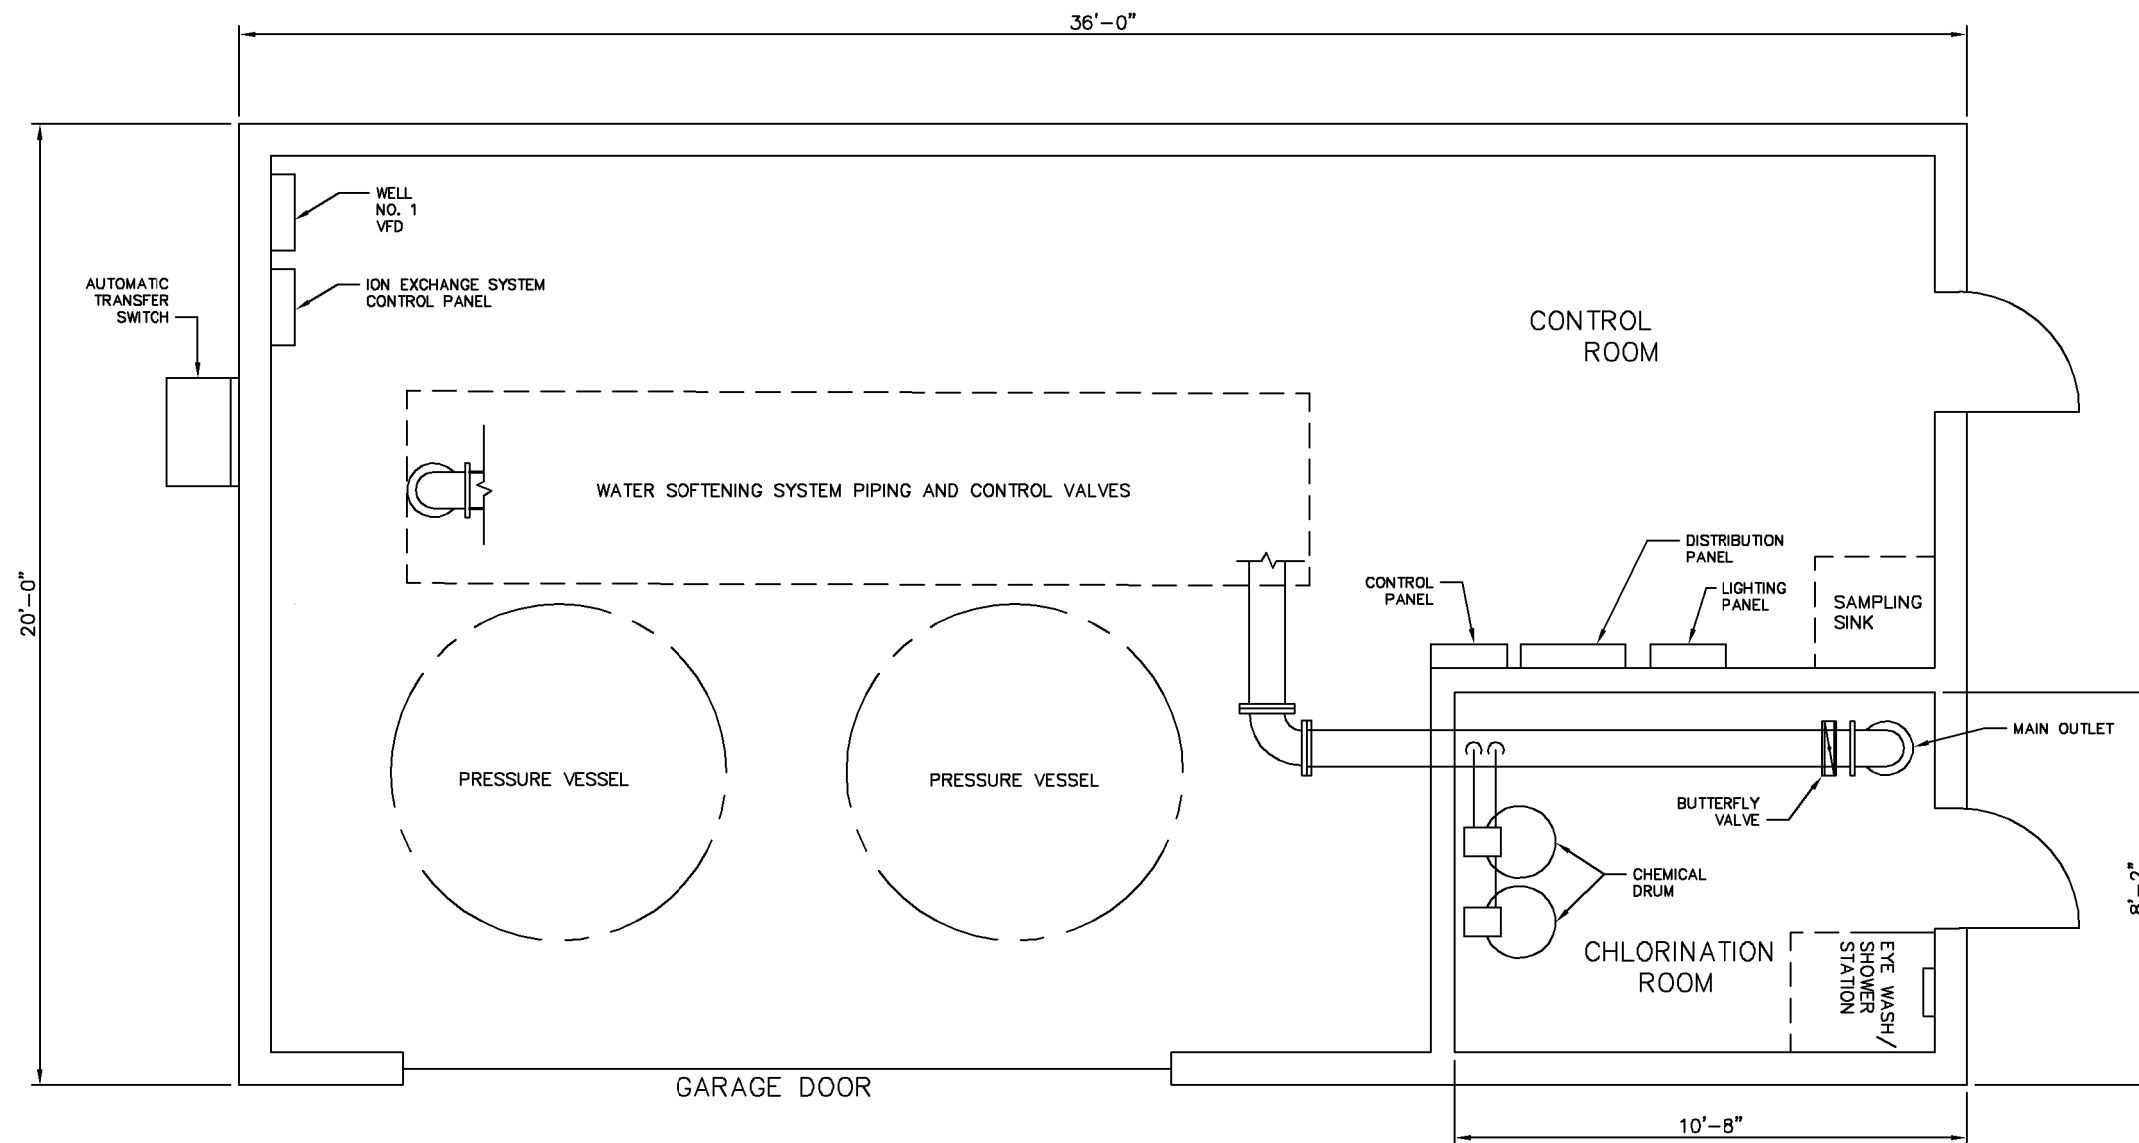
Figure 4

Preliminary Softening Treatment Building Floor Plan

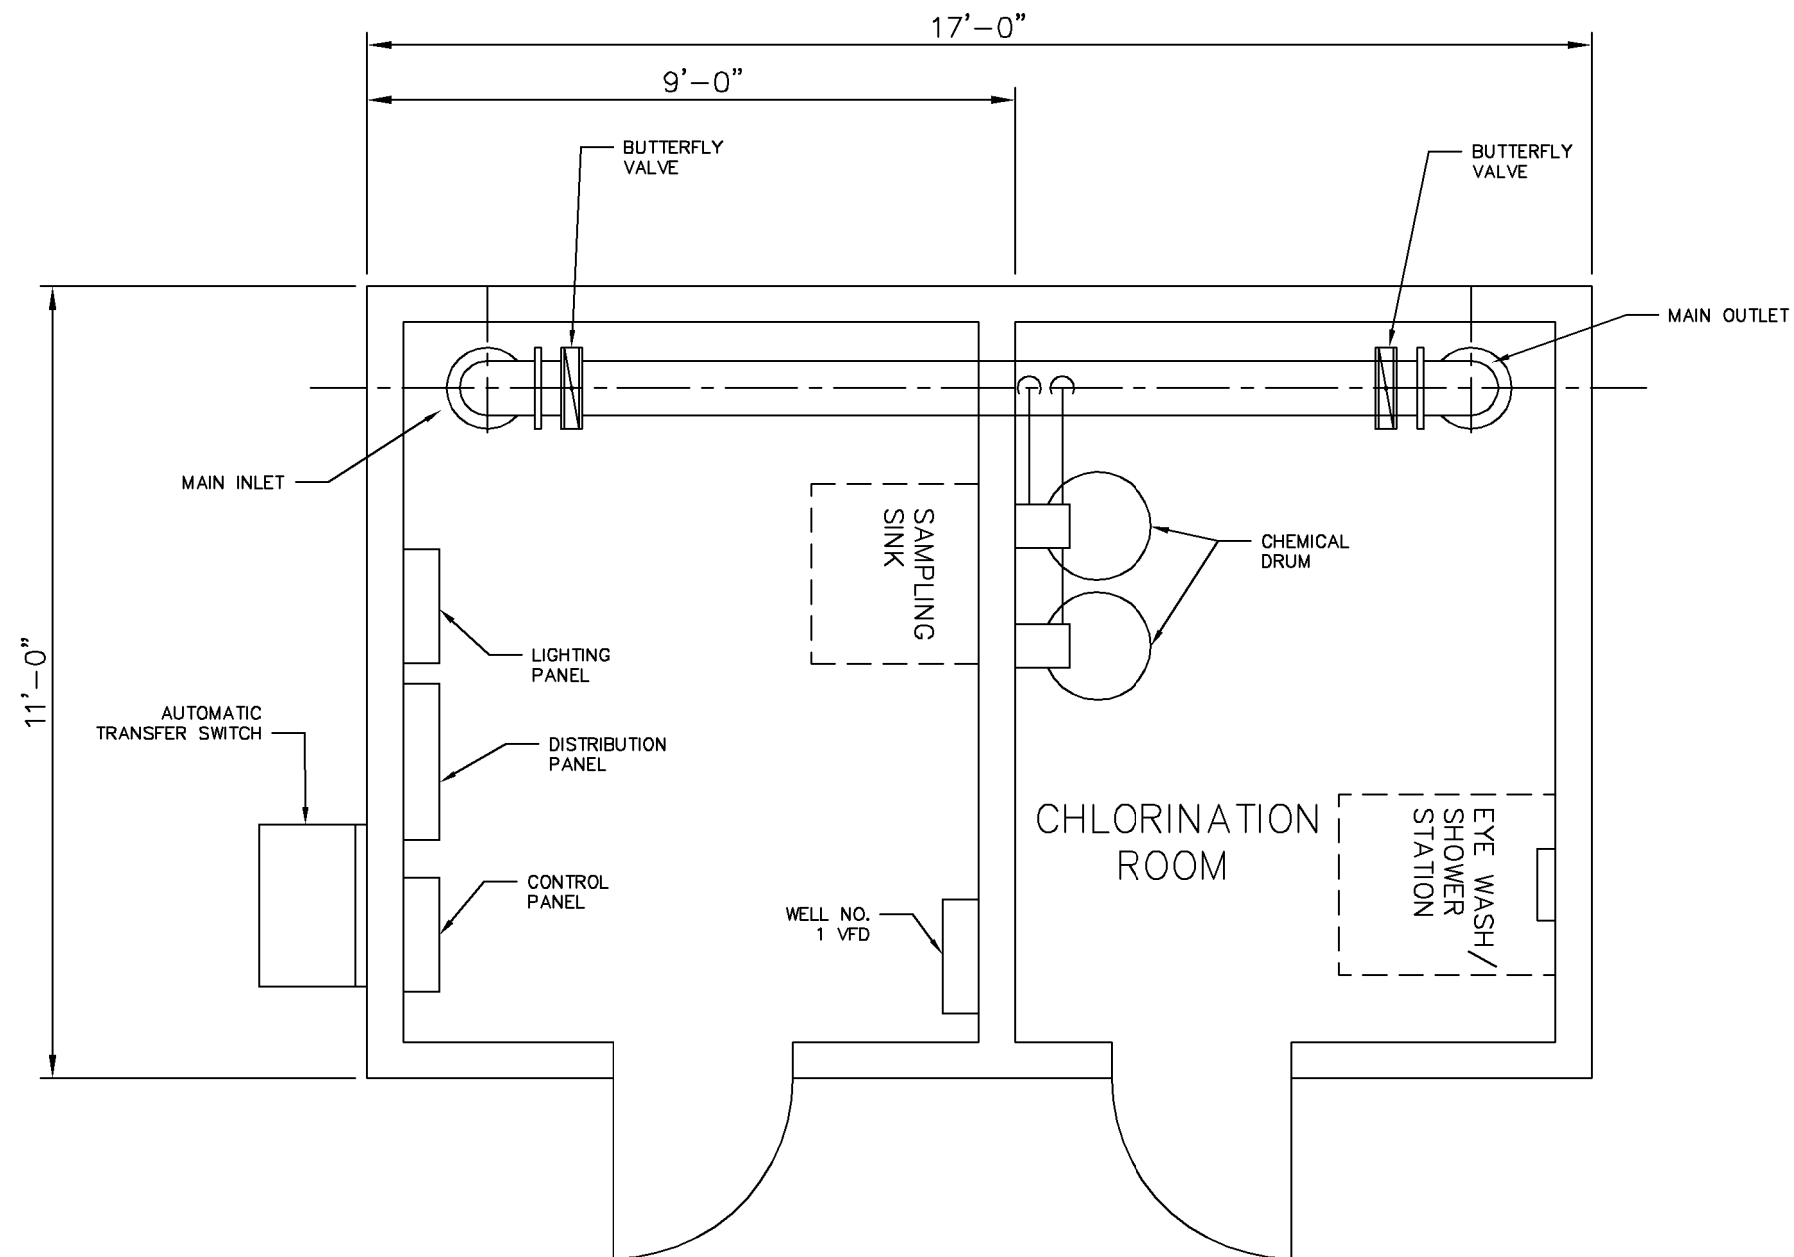
Figure 5

Preliminary Treatment Building Floor Plan

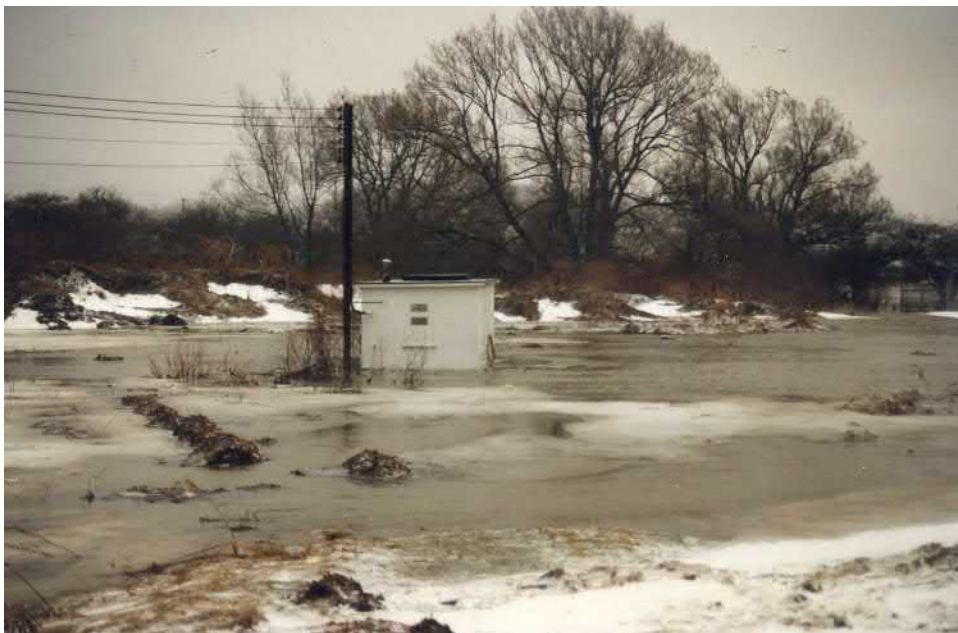
Well house #2 during a spring flood ~2000 – photo taken from the driveway. The monitoring well that requires proper abandonment and plugging is near the big tree.

There is a monitoring well located in the vicinity of Well House No. 2 that has been reported by the CCDOH to be damaged. The CCDOH has issued a violation for the condition of this monitoring well as it must be properly abandoned and plugged to eliminate the potential contamination of the aquifer during flooding events. The CCDOH cited NYSDOH Subpart 5-1.71b as a basis for this violation.

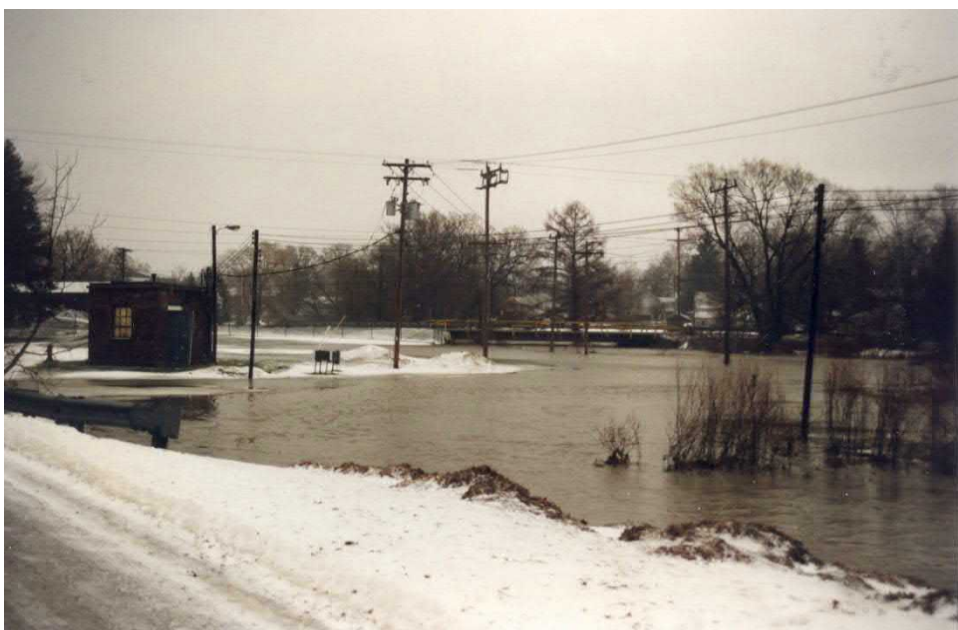
Well house #1 taken on same day as above photo.

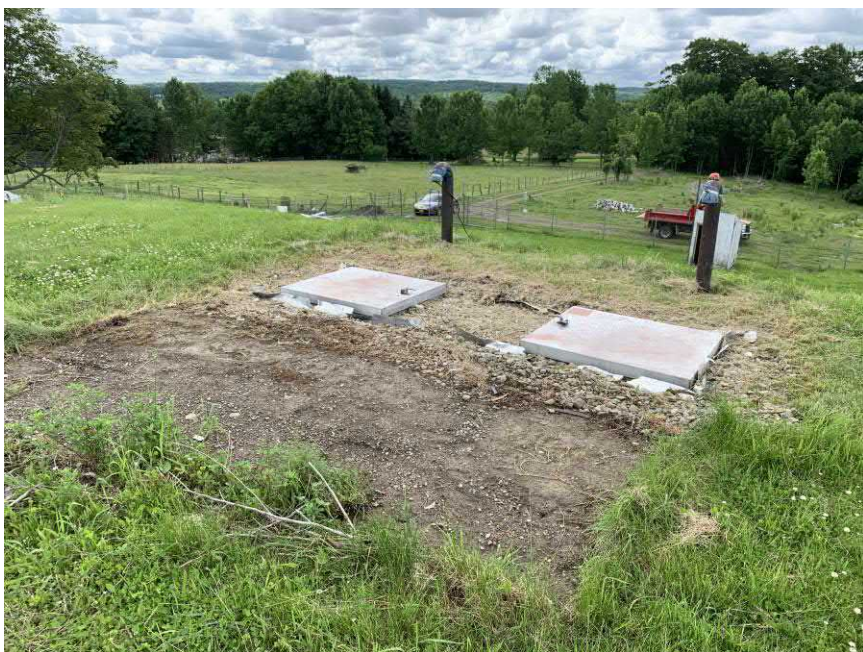
6/18/19 Storage tank access hatches.

- The tank access hatches on the top of the water tank are located at the same elevation as the grass/sod that covers the water storage tank. The access hatches should be raised a minimum of 24-inches above the top of the tank and covering sod, so that rain water cannot easily penetrate into the storage tank. The current set up puts the drinking water system at risk of surface water contamination. The CCDOH has issued a violation for the access hatches citing Subpart 5-1 Appendix A Section 7.0.8.2 as a basis for the violation.

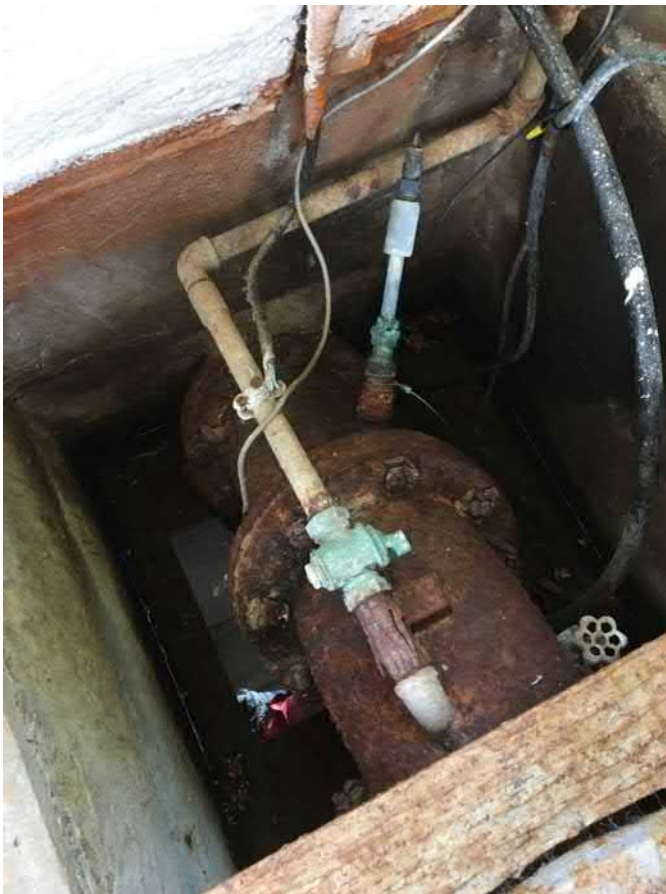
Well House No.1
Chlorine Injection Corp
